Information on Status of Nuclear Power Plants in Fukushima

Japan Atomic Industrial Forum, Inc.

Status of nuclear power plants in Fukushima as of 20:00, April 13th (Estimated by JAIF)

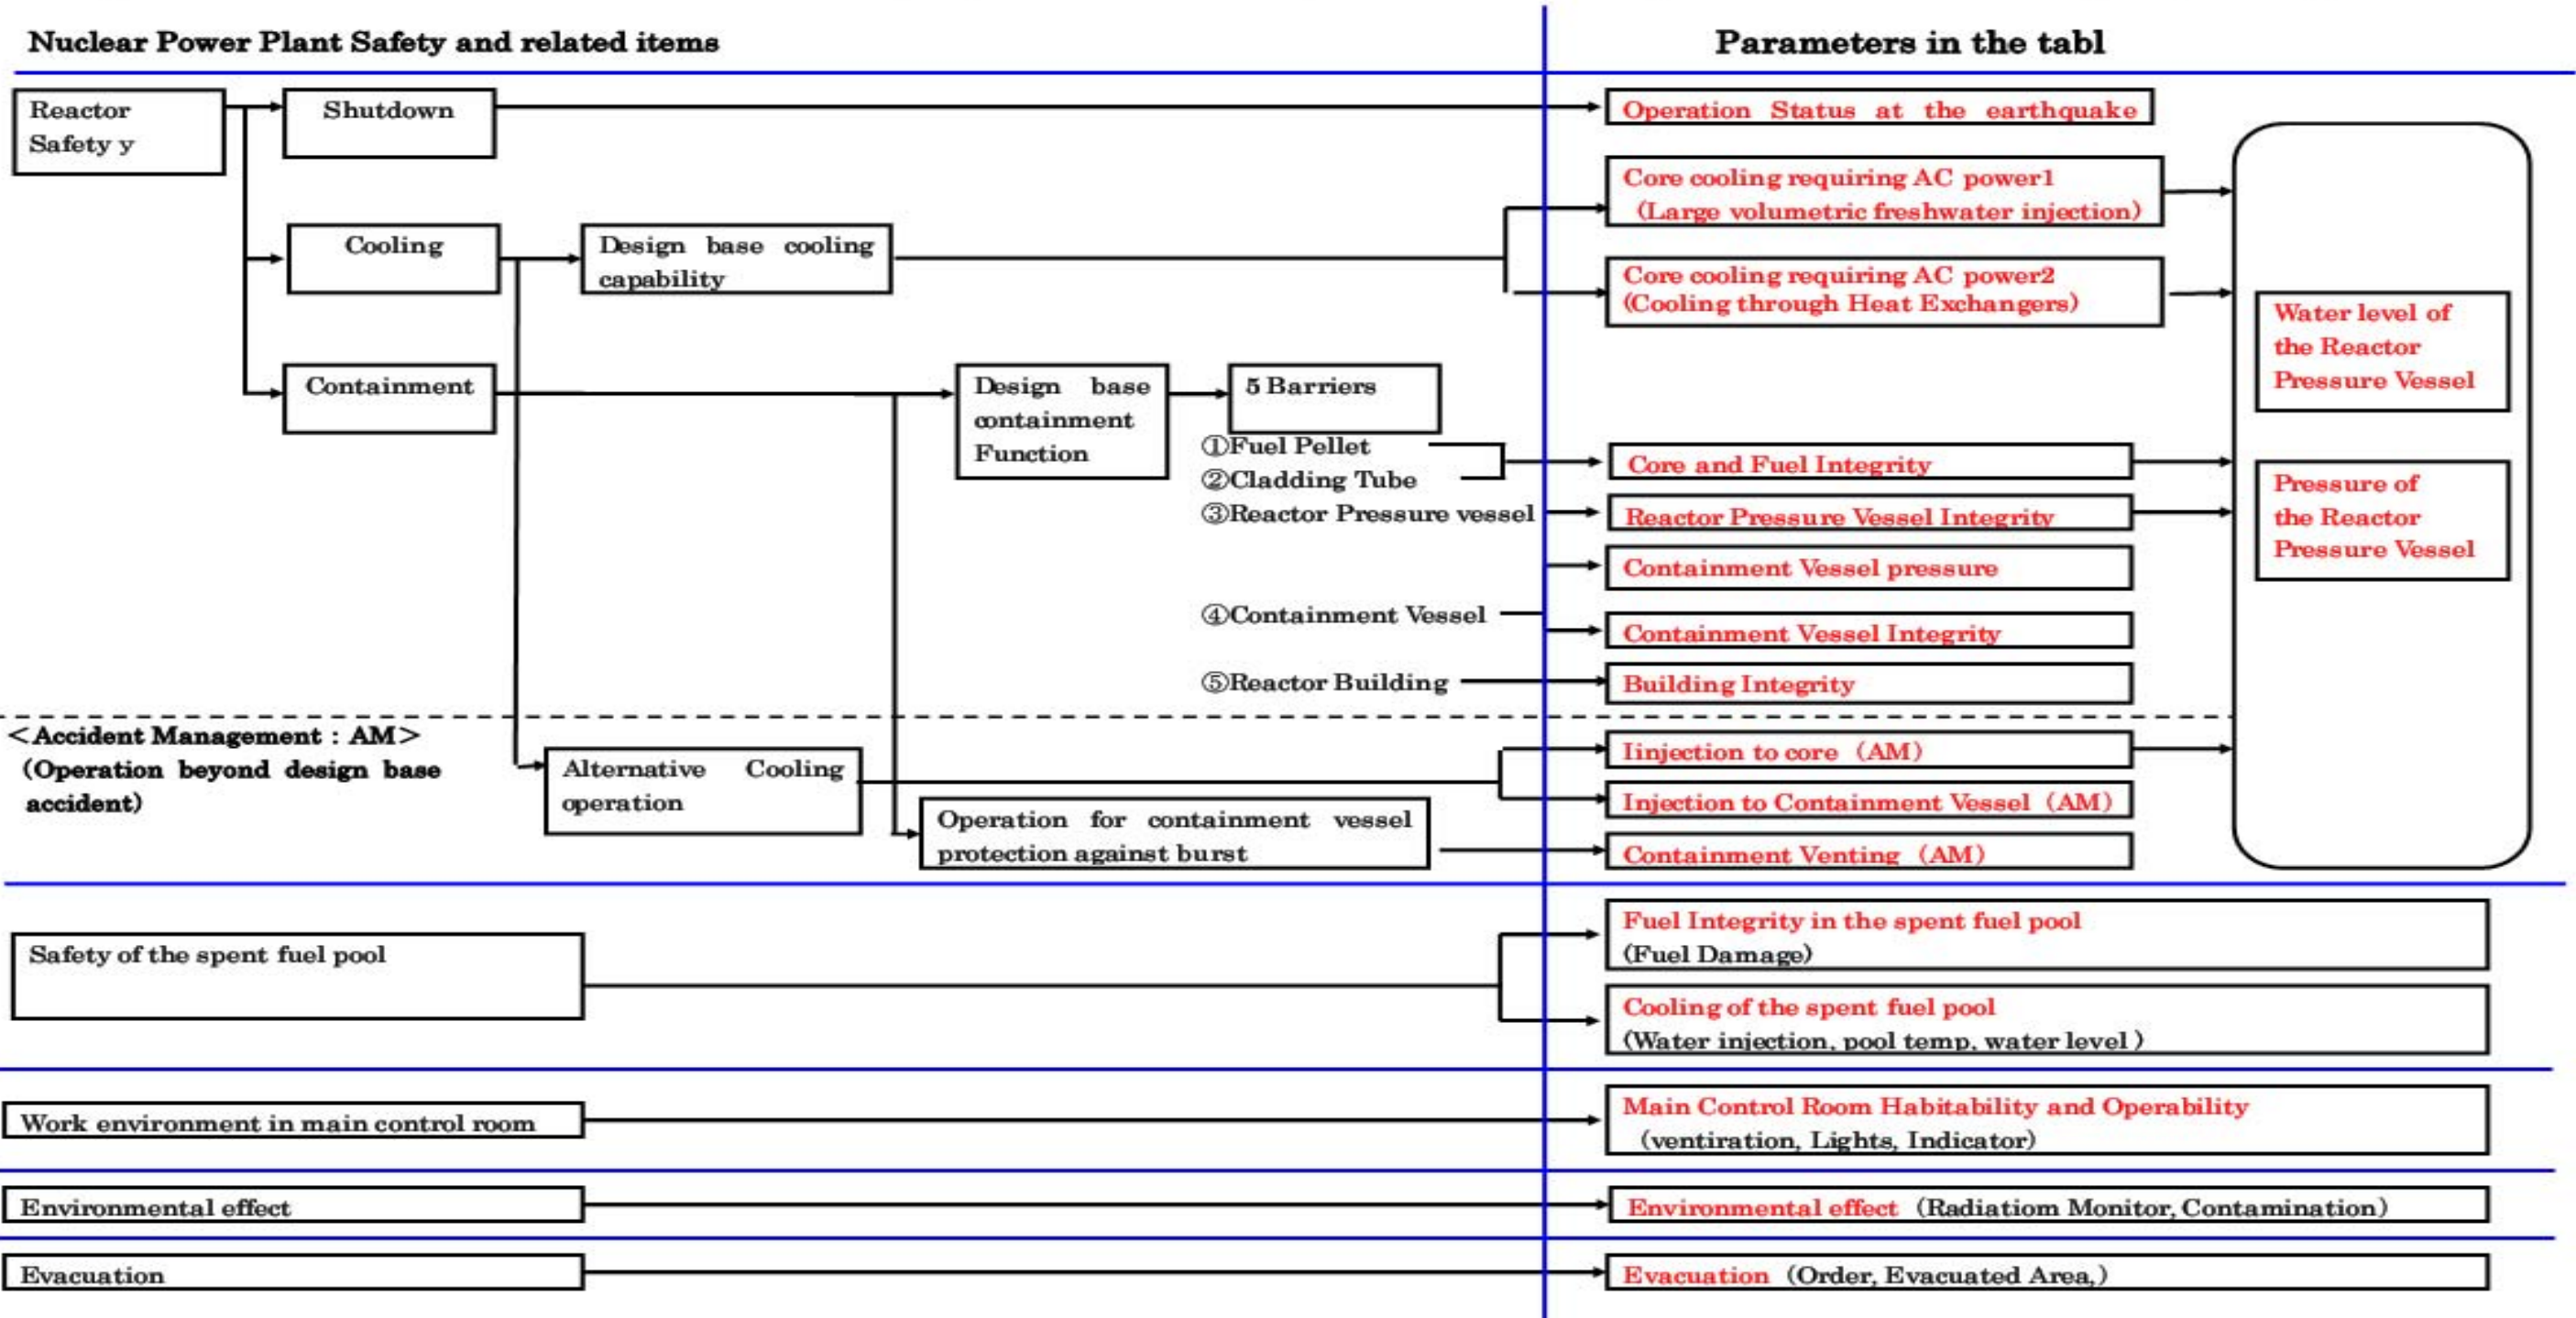
Parameters in the Table

JALF picks up these parameters to evaluate safety condition of the nuclear plants during this accident from the view point of the principles of nuclear power plant safety, which are "Shutdown", "Cooling" and "Containment". Then we create the chart. The following diagram is to show the correspondence relation of these parameters in the table to nuclear power plant safety.
