Information on Status of Nuclear Power Plants in Fukushima

Japan Atomic Industrial Forum, Inc.

Status of nuclear power plants in Fukushima as of 18:00, April 3rd (Estimated by JAIF)

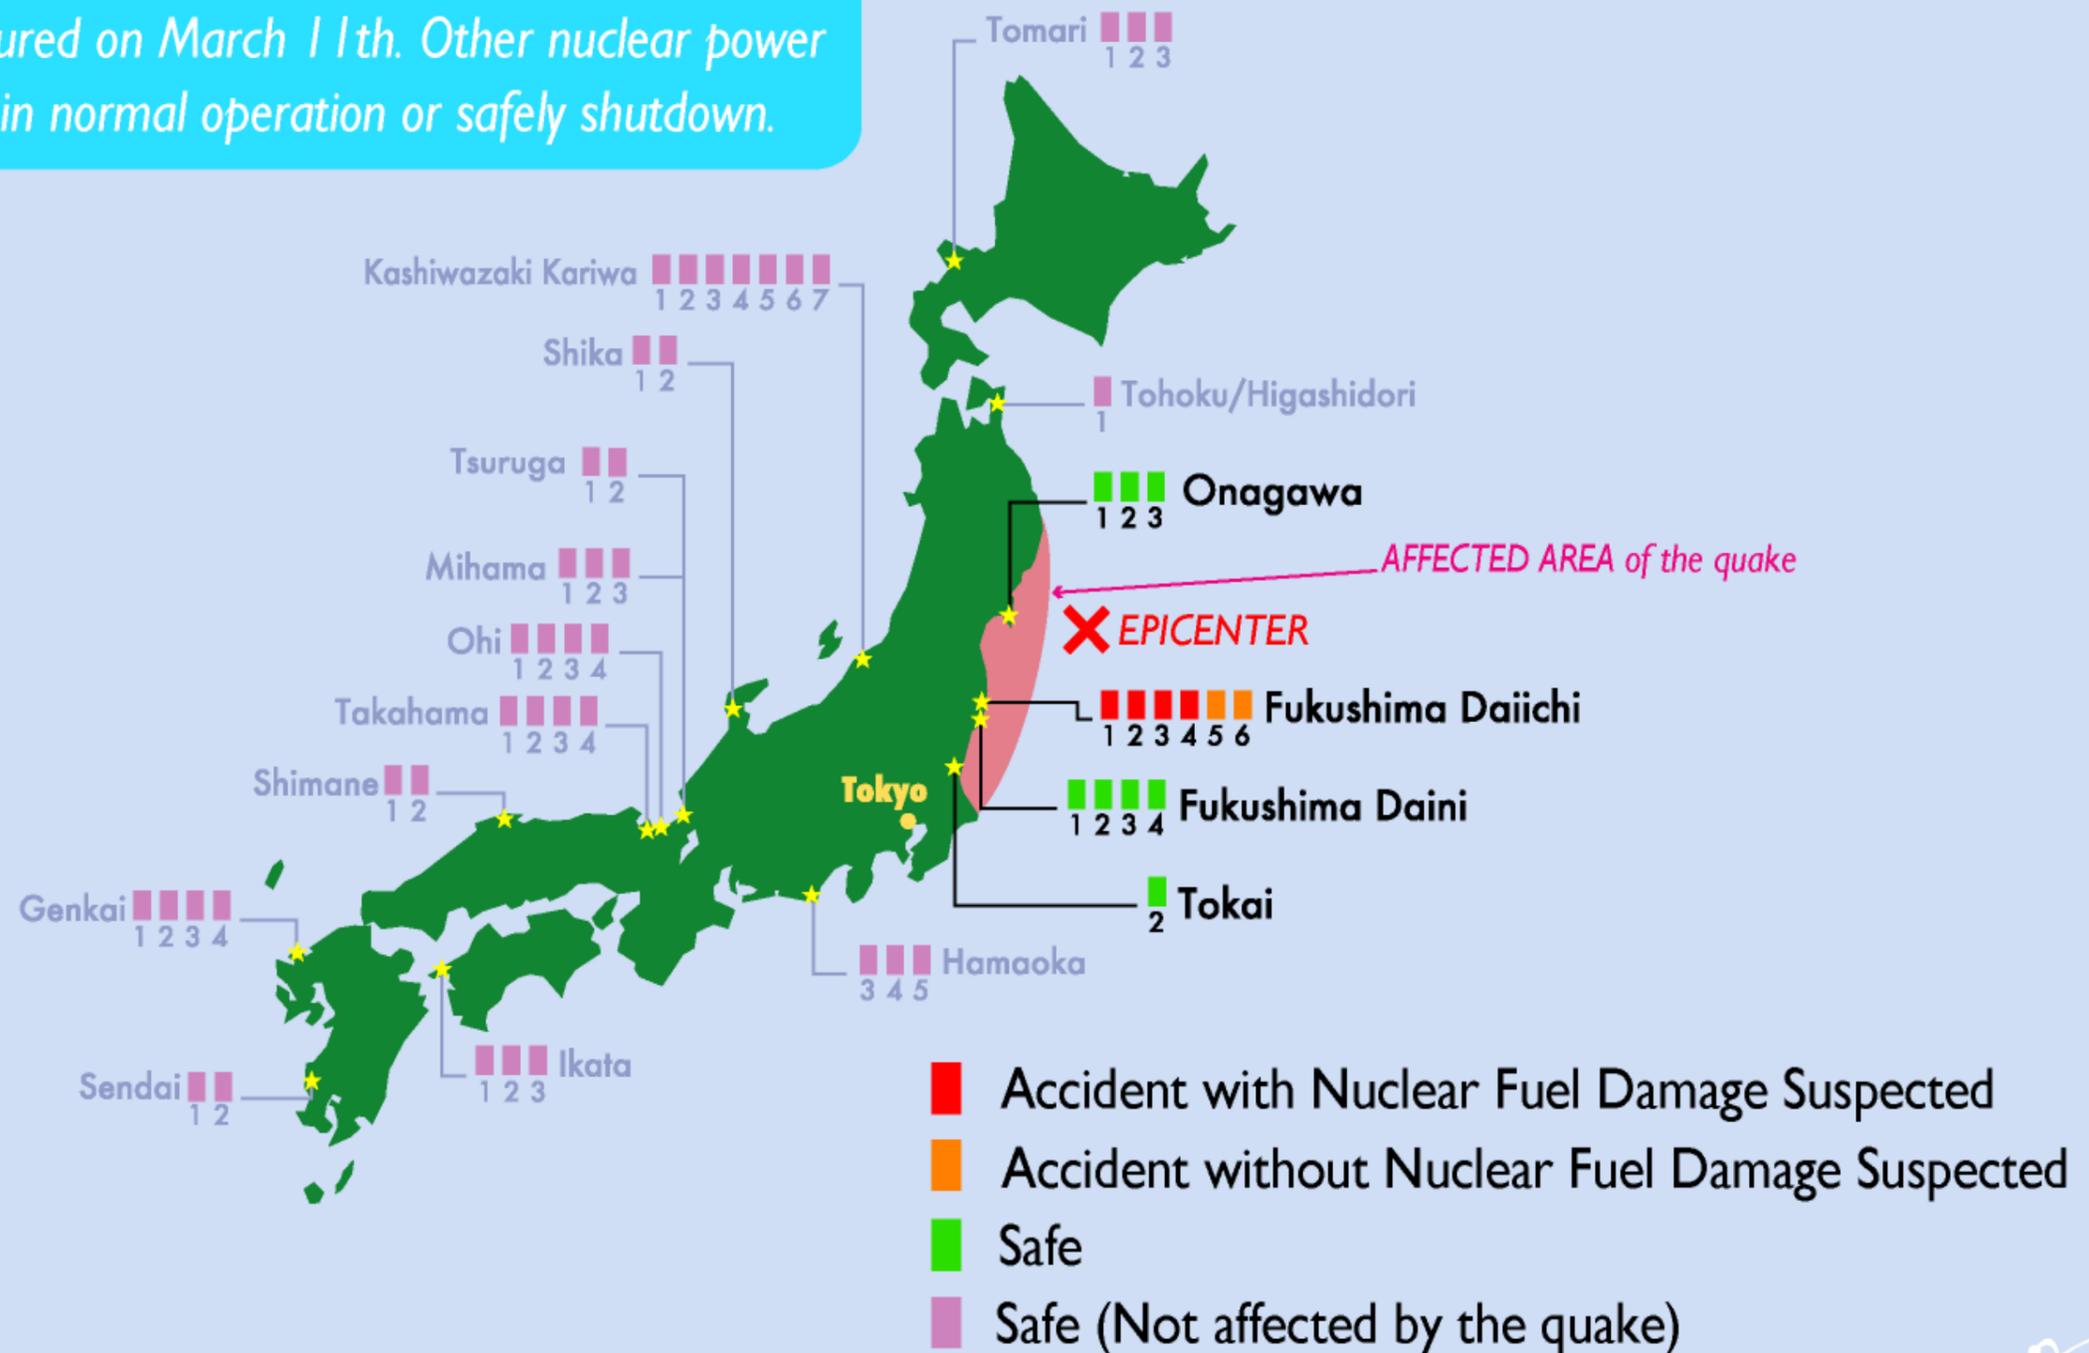
Status of the Nuclear Power Plants after the Earthquake

The accident that brings environmental impact is going on at several units in Fukushima Daiichi nuclear power Station after the earthquake occurred on March 11th. Other nuclear power plants in Japan are in normal operation or safely shutdown.
