Information on Status of Nuclear Power Plants in Fukushima

Japan Atomic Industrial Forum, Inc.

Status of nuclear power plants in Fukushima as of 12:00, April 23nd (Estimated by JAIF)

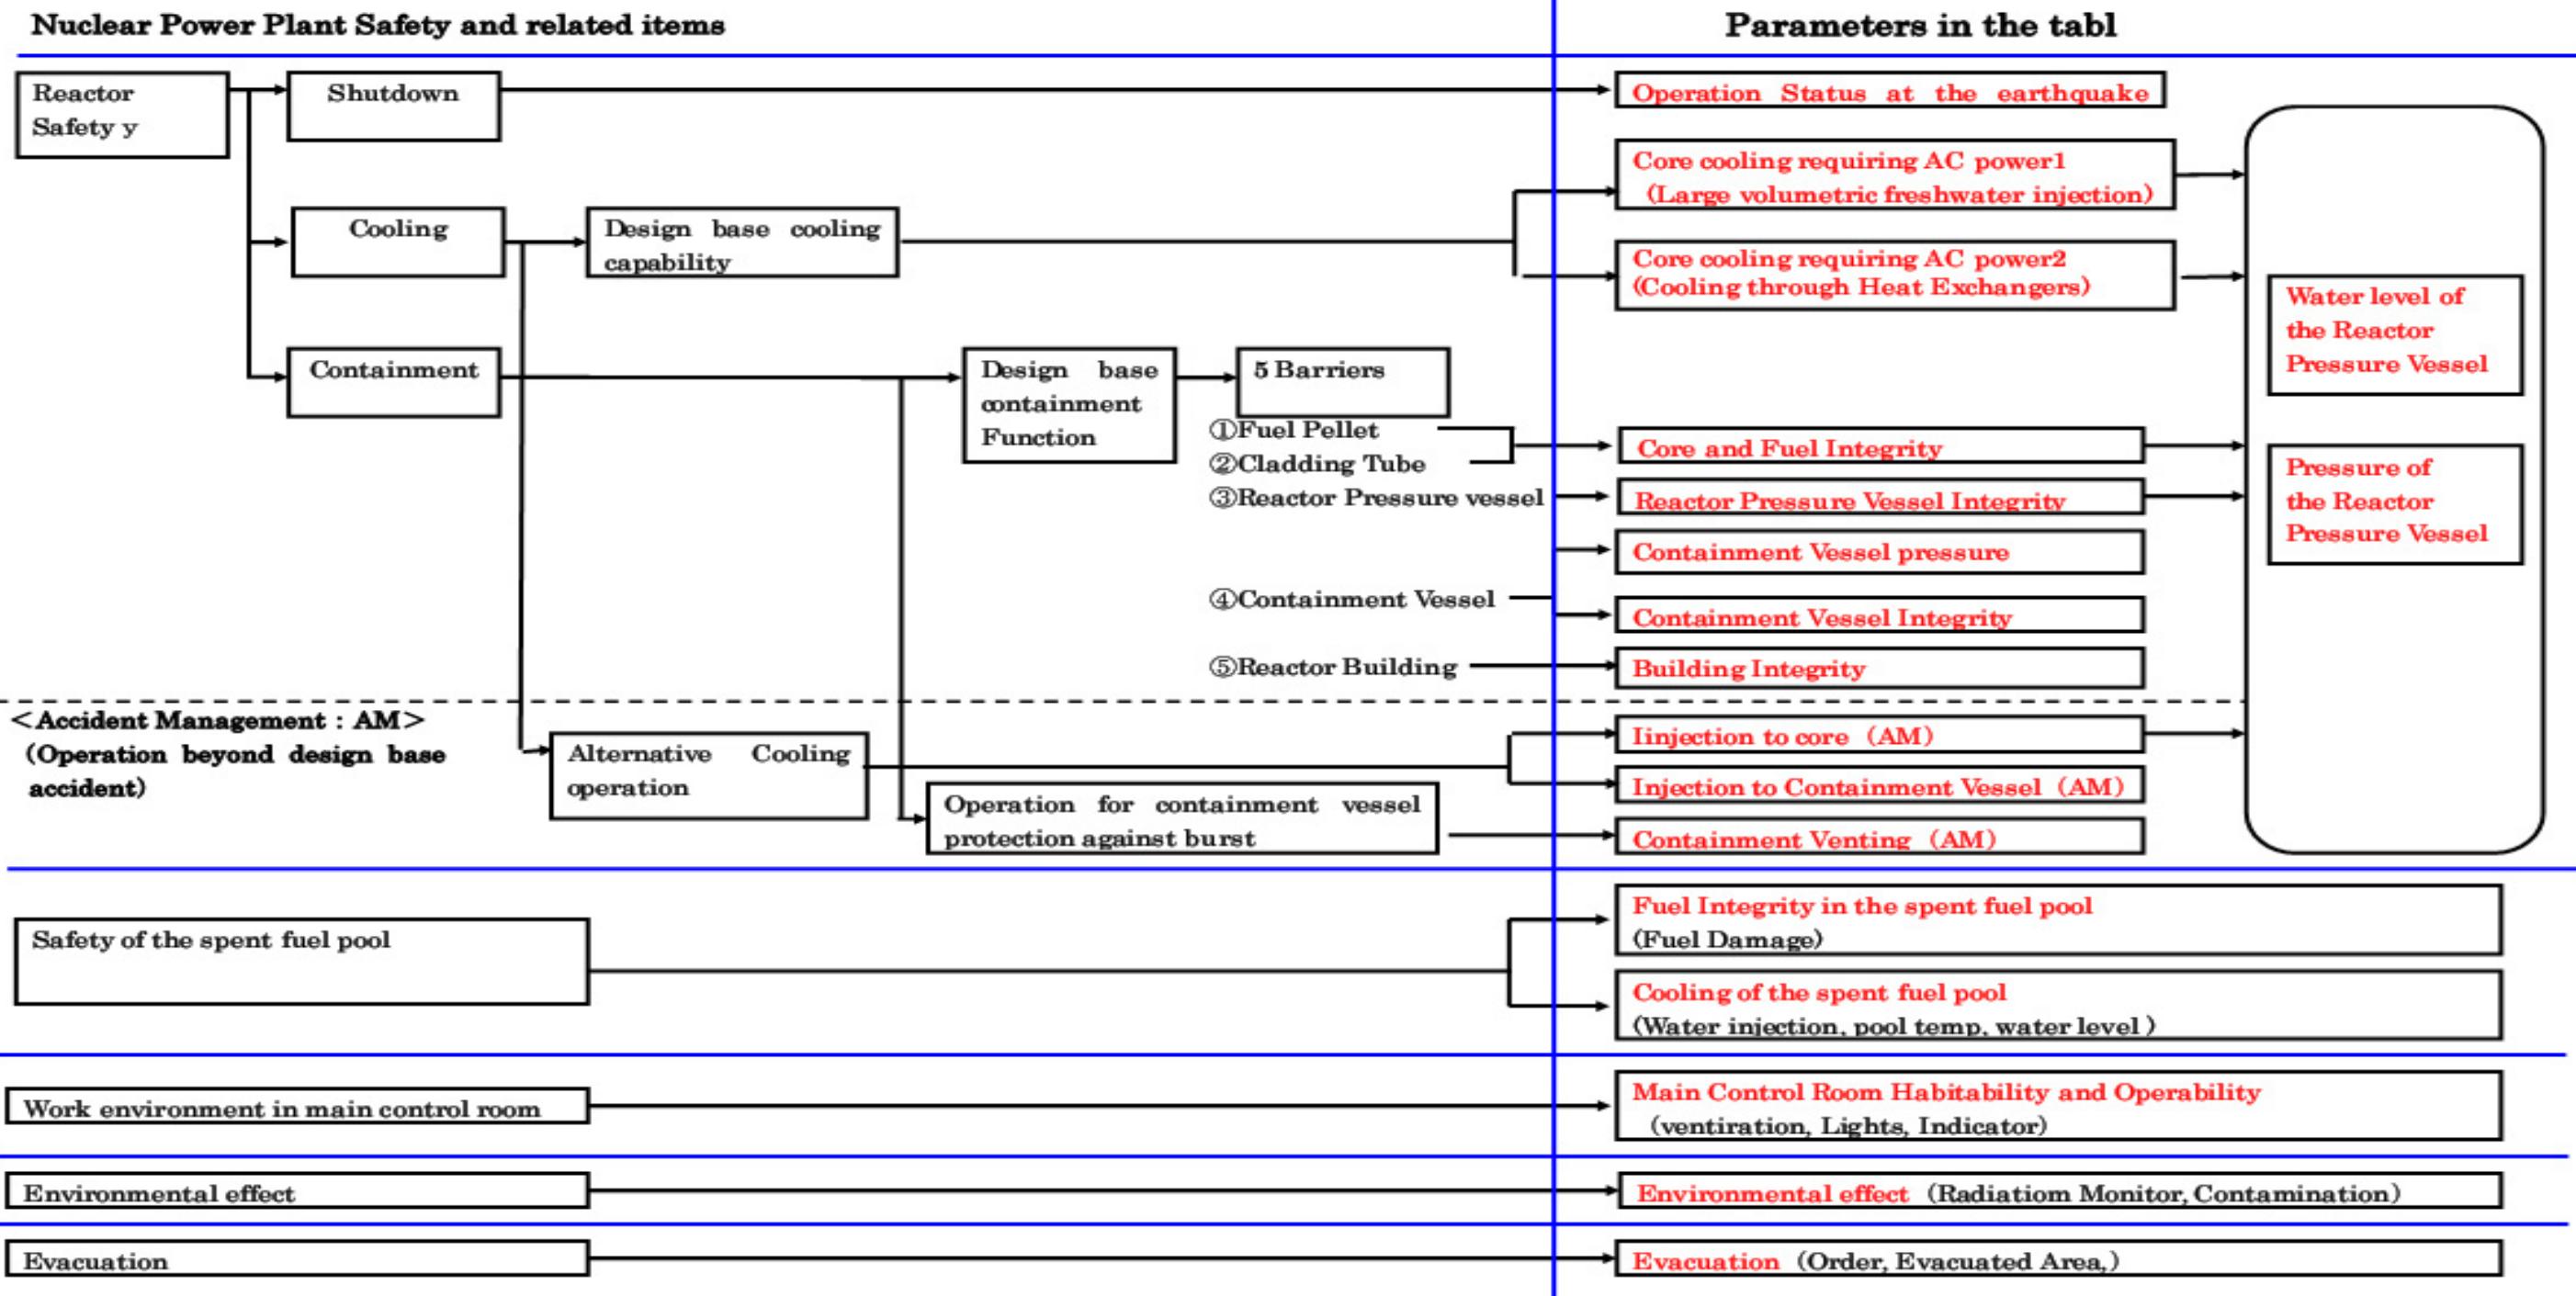
Parameters in the Table

JAIF picks up these parameters to evaluate safety condition of the nuclear plants during this accident from the view point of the principles of nuclear power plant safety, which are "Shutdown", "Cooling" and "Containment". Then we create the chart. The following diagram is to show the correspondence relation of these parameters in the table to nuclear power plant safety.
