# Information on Status of Nuclear Power Plants in Fukushima

Japan Atomic Industrial Forum, Inc.

Status of nuclear power plants in Fukushima as of 12:00, May 1st (Estimated by JAIF)

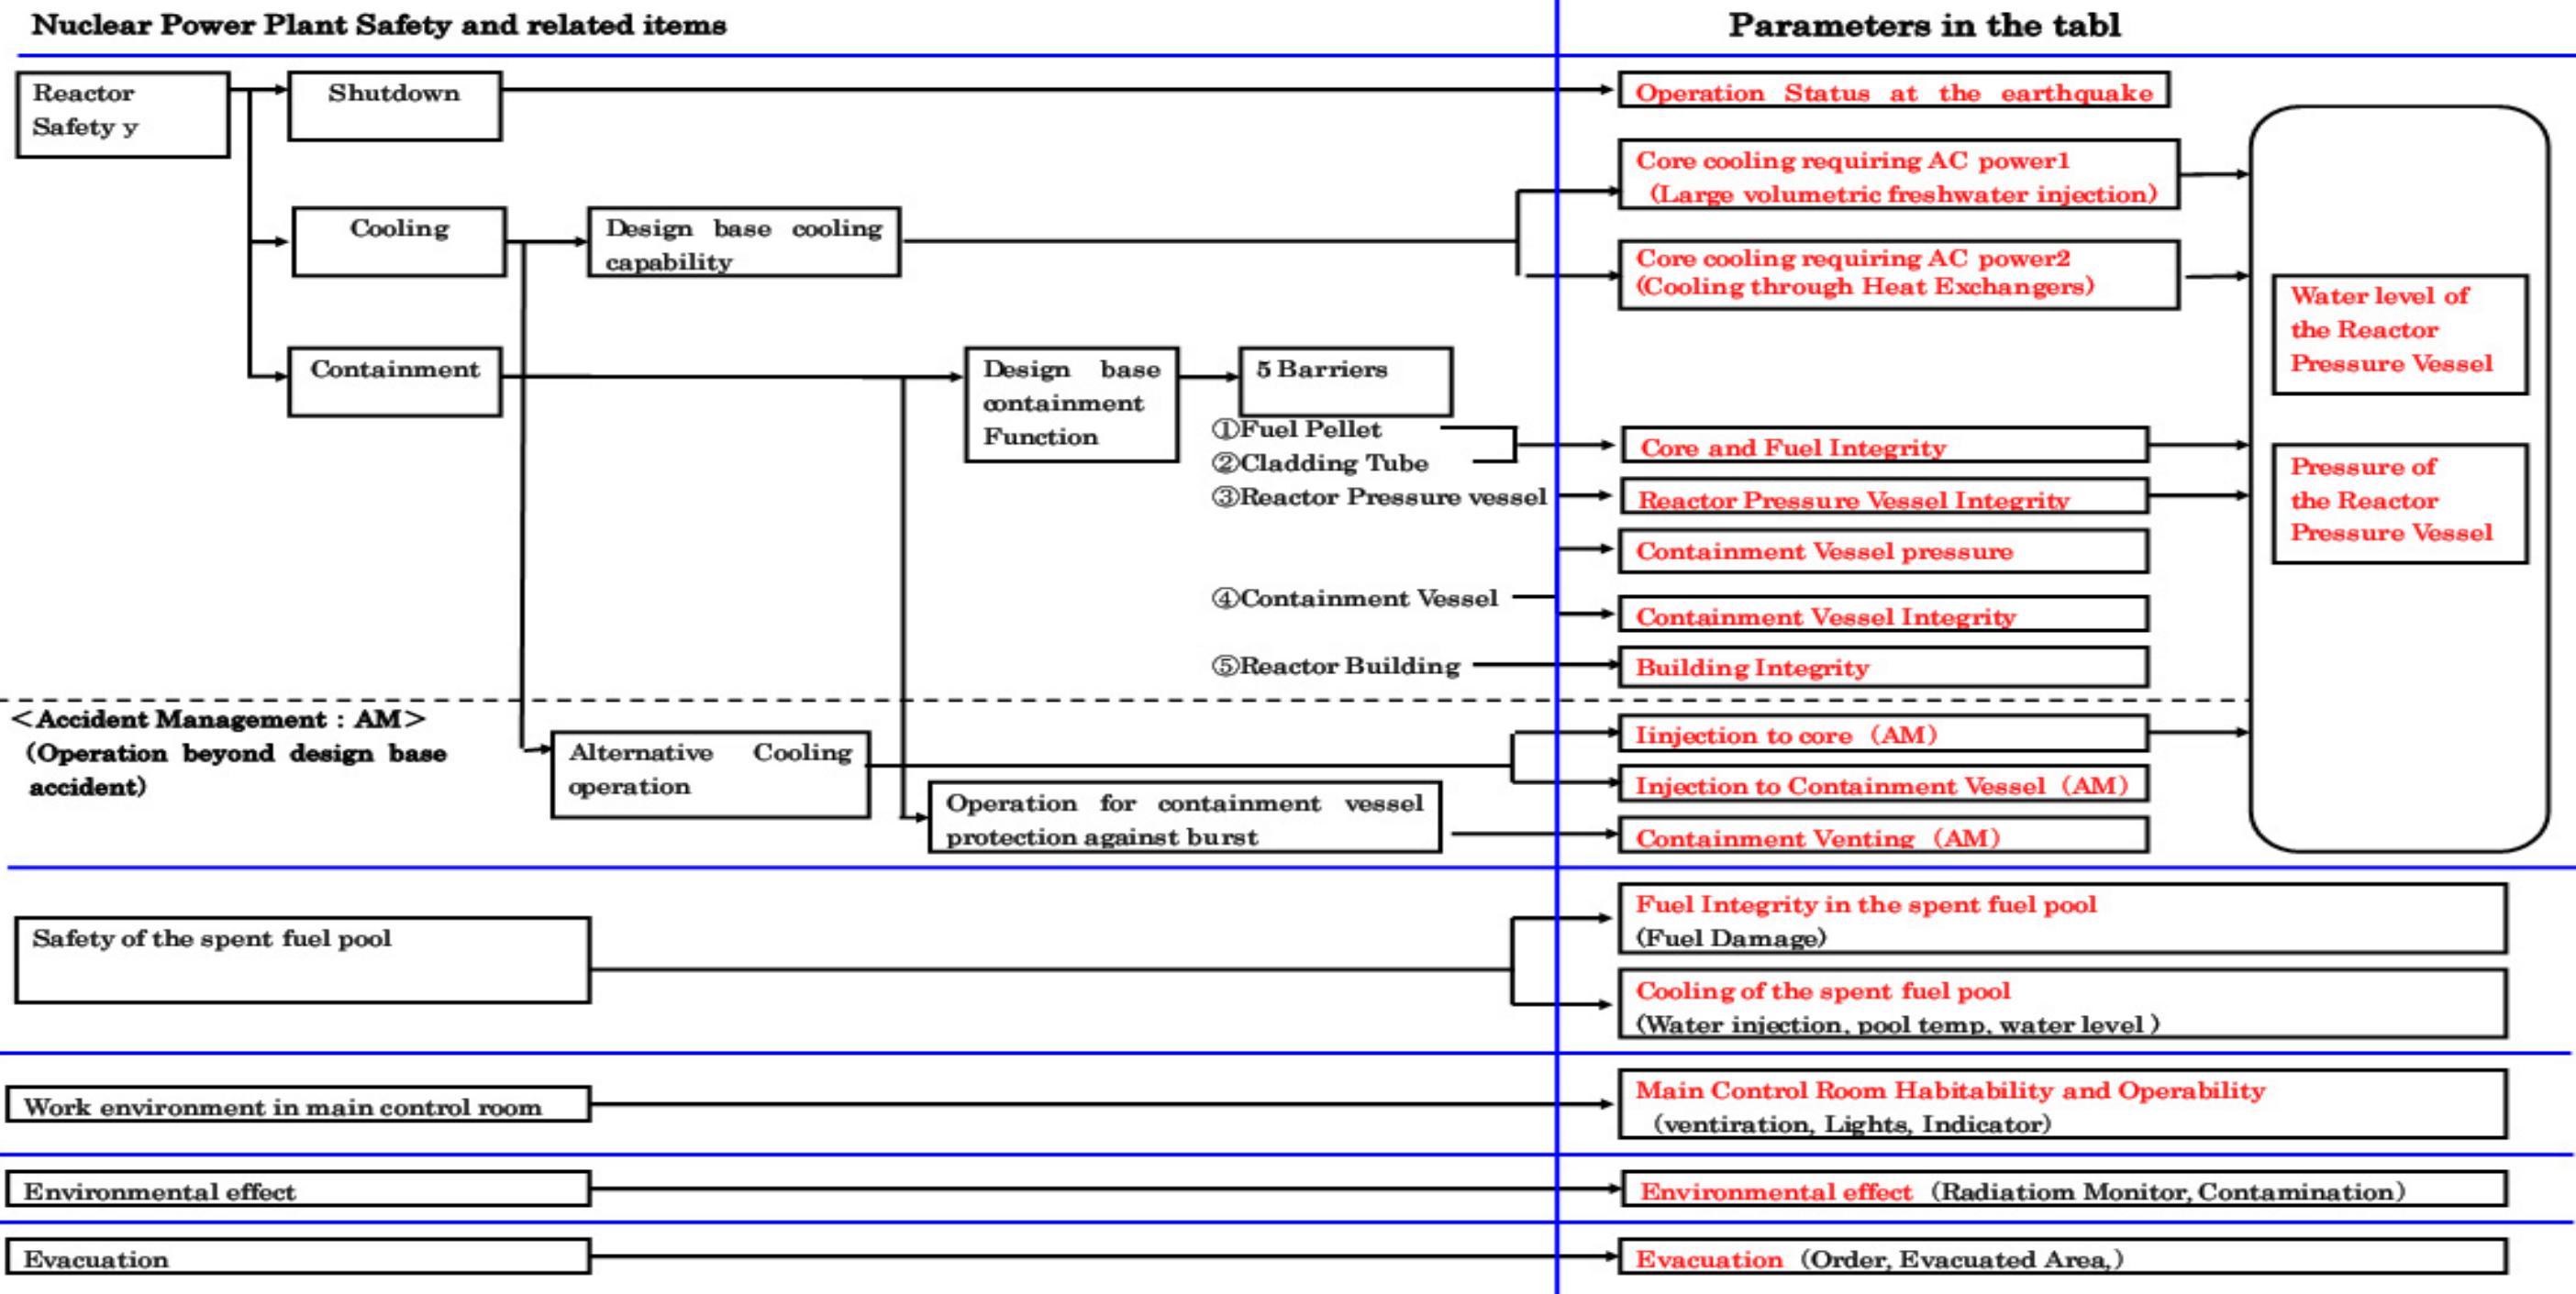
JAIF picks up these parameters to evaluate safety condition of the nuclear plants during this accident from the view point of the principles of nuclear power plant safety, which are "Shutdown", "Cooling" and "Containment". Then we create the chart. The following diagram is to show the correspondence relation of these parameters in the table to nuclear power plant safety.
