Information on Status of Nuclear Power Plants in Fukushima

Japan Atomic Industrial Forum, Inc.

Status of nuclear power plants in Fukushima as of 21:00, April 1st (Estimated by JAIF)

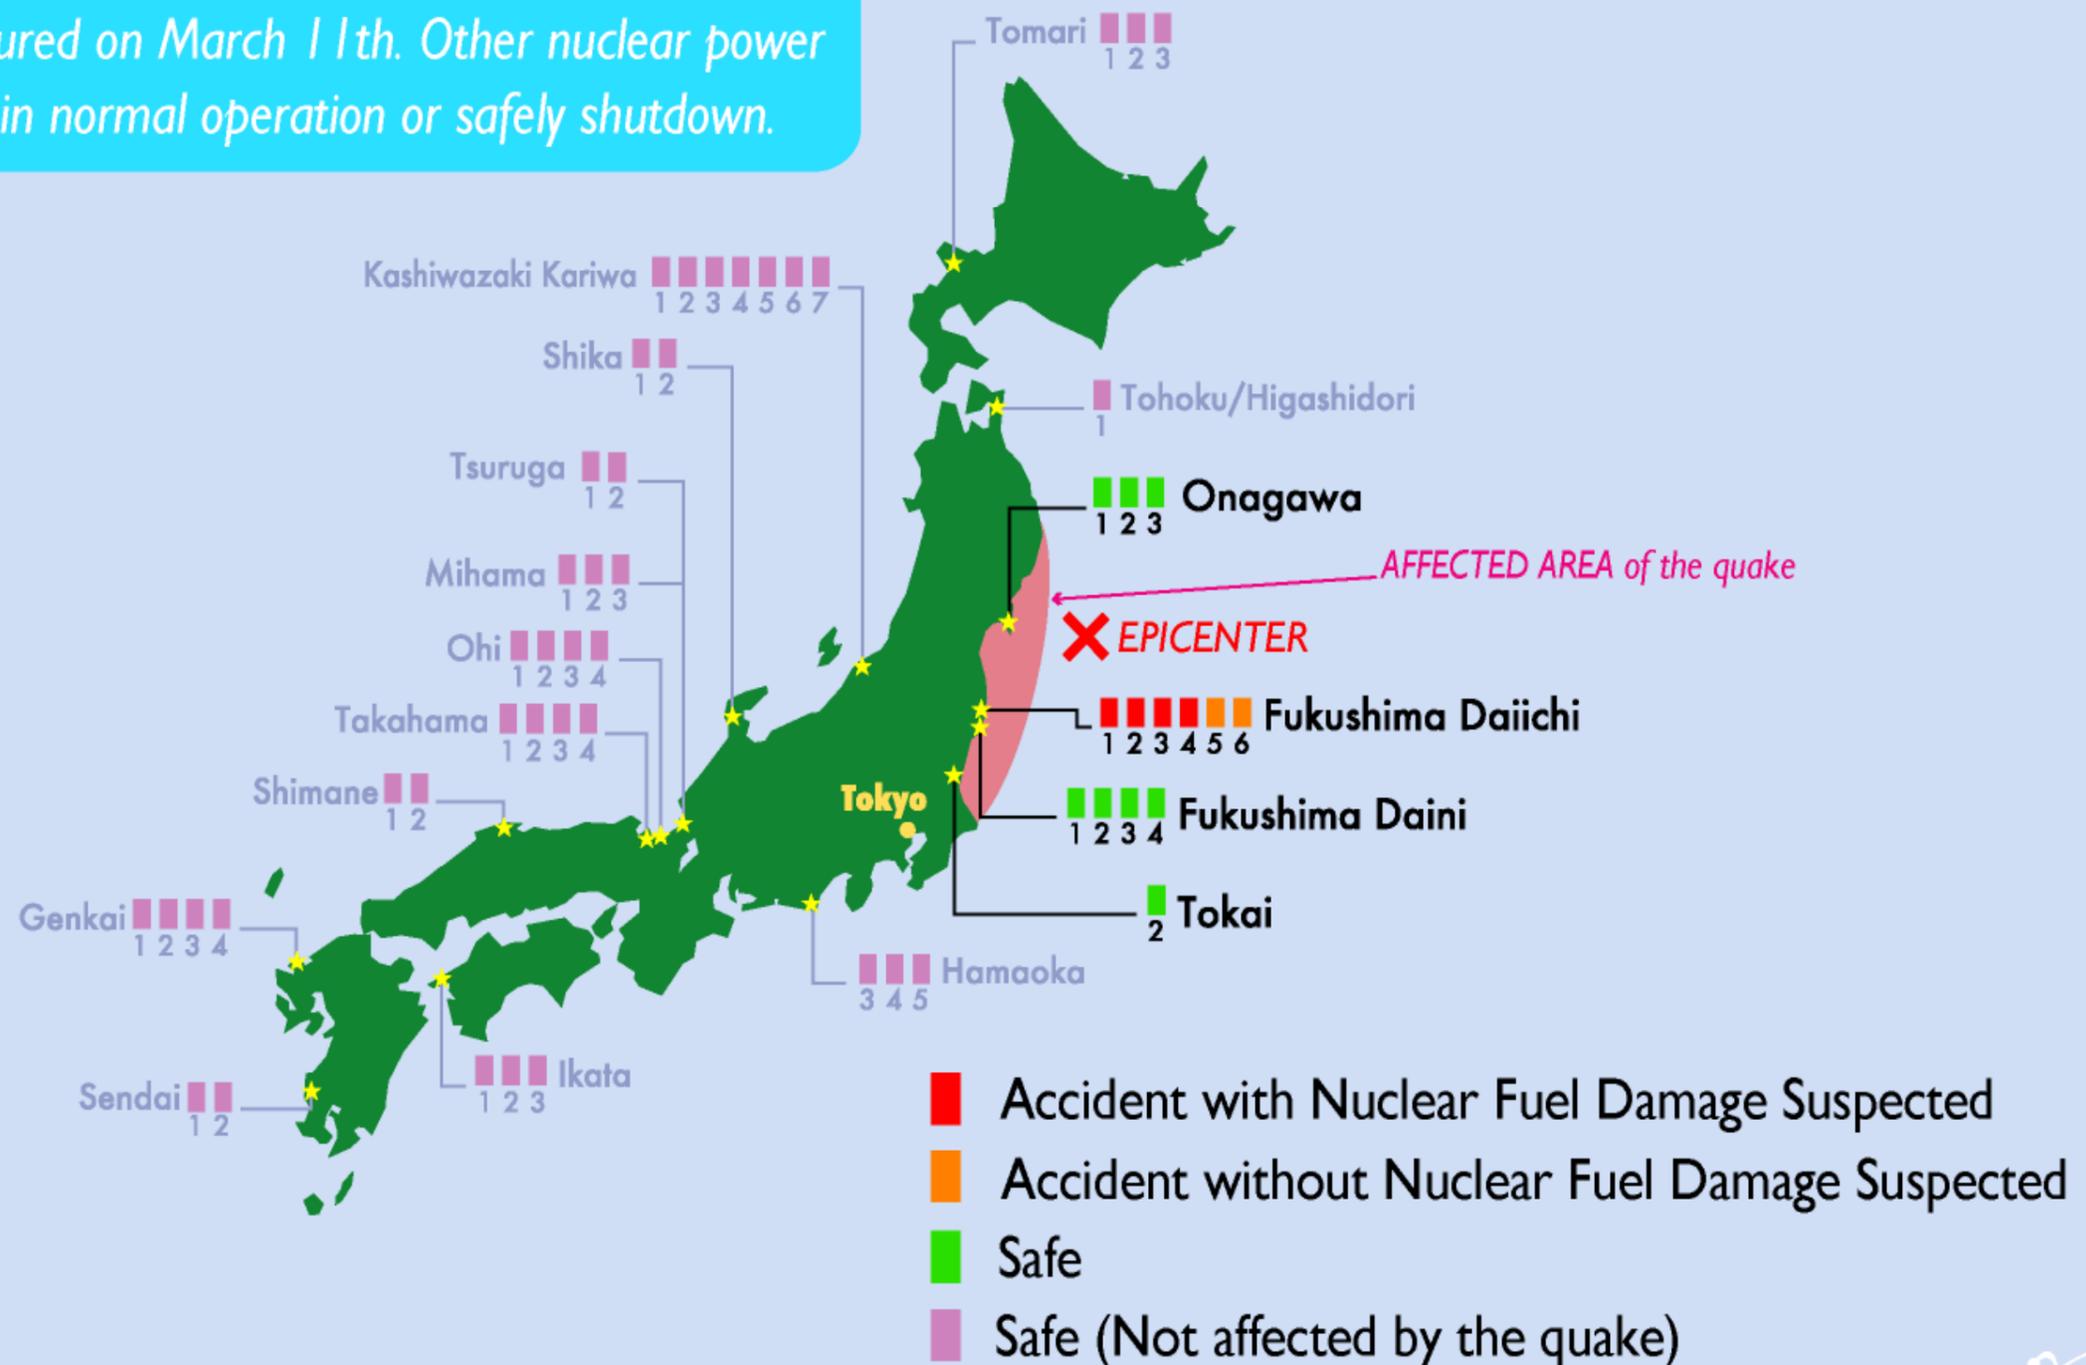
Status of the Nuclear Power Plants after the Earthquake

The accident that brings environmental impact is going on at several units in Fukushima Daiichi nuclear power Station after the earthquake occurred on March 11th. Other nuclear power plants in Japan are in normal operation or safely shutdown.
