Information on Status of Nuclear Power Plants in Fukushima

Japan Atomic Industrial Forum, Inc.

Status of nuclear power plants in Fukushima as of 12:00, April 27th (Estimated by JAIF)

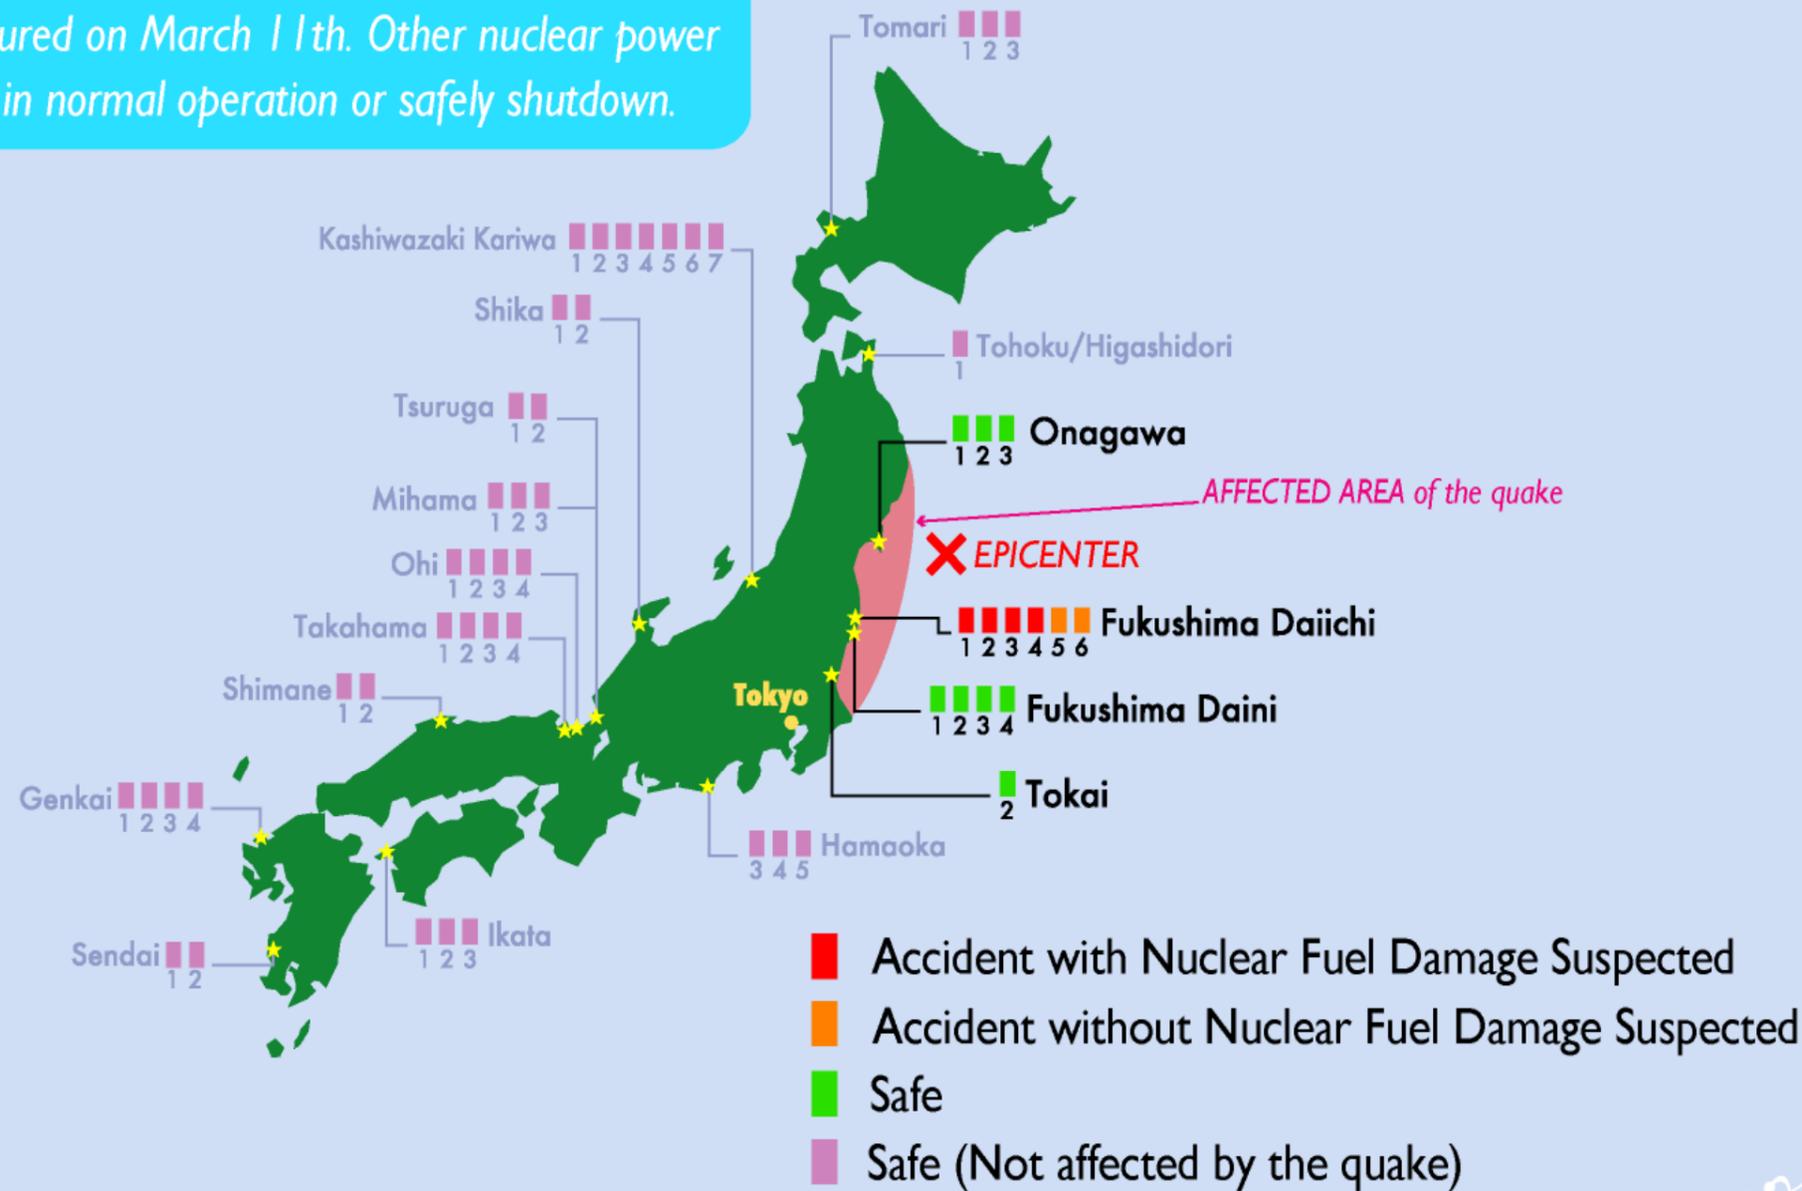
Status of the Nuclear Power Plants after the Earthquake

The accident that brings environmental impact is going on at several units in Fukushima Daiichi nuclear power Station after the earthquake occurred on March 11th. Other nuclear power plants in Japan are in normal operation or safely shutdown.
