Status of nuclear power plants in Fukushima as of 10:00 March 24 (Estimated by JAIF)

Status of the Nuclear Power Plants after the Earthquake

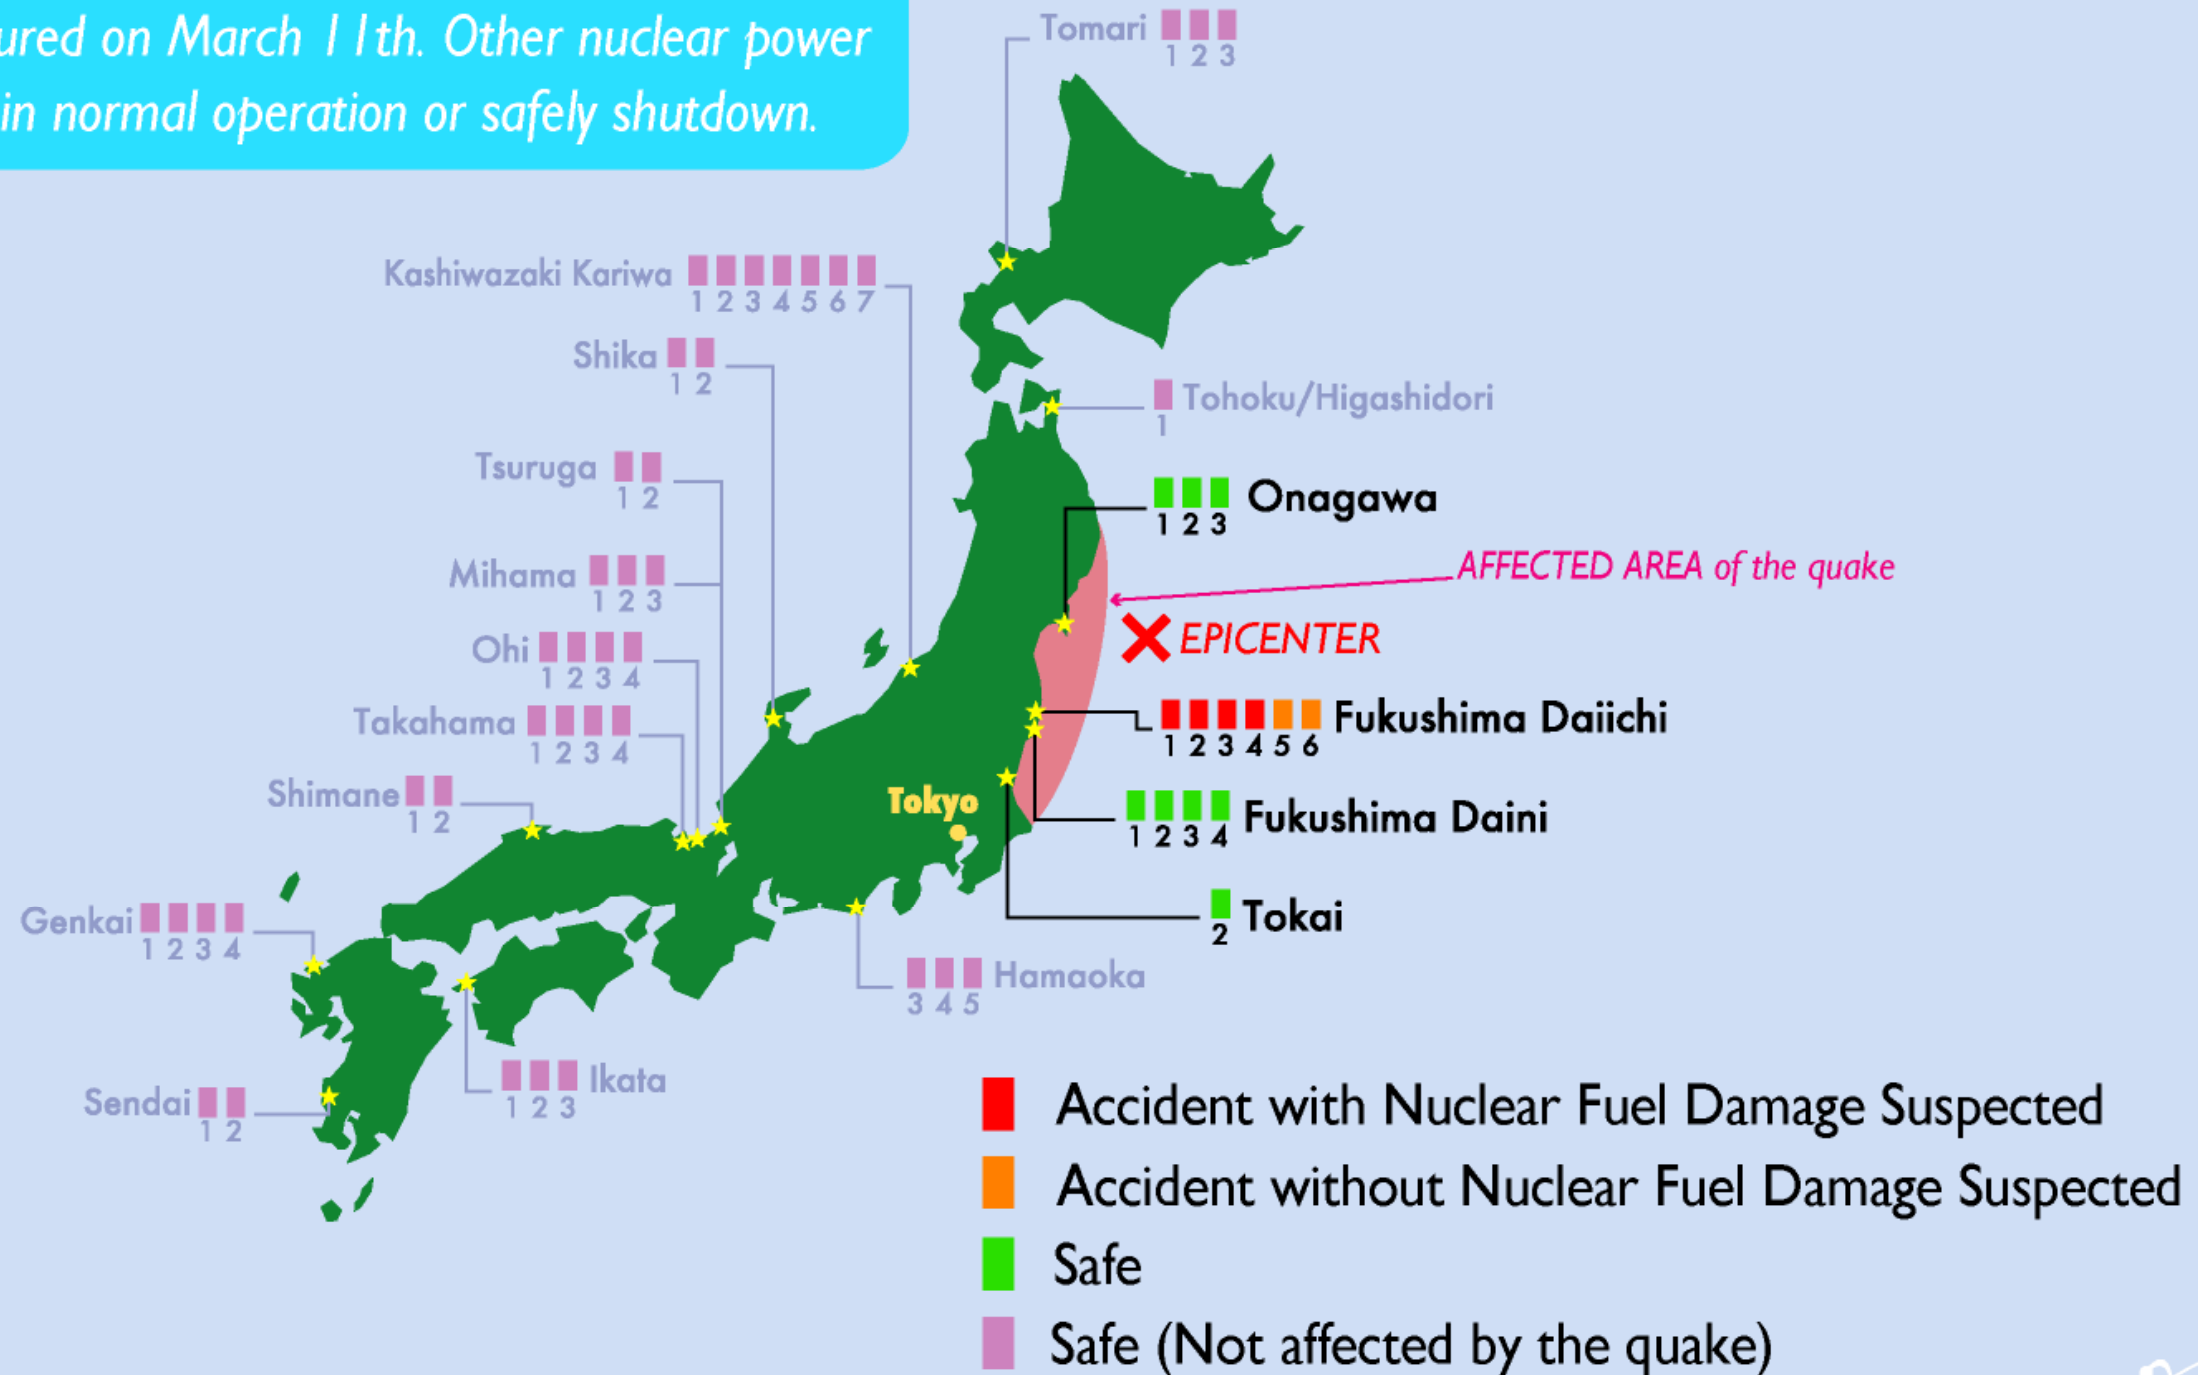
The accident that brings environmental impact is going on at several units in Fukushima Daiichi nuclear power Station after the earthquake occurred on March 11th. Other nuclear power plants in Japan are in normal operation or safely shutdown.
