Status of nuclear power plants in Fukushima as of 10:00 March 25 (Estimated by JAIF)

Parameters in the Table

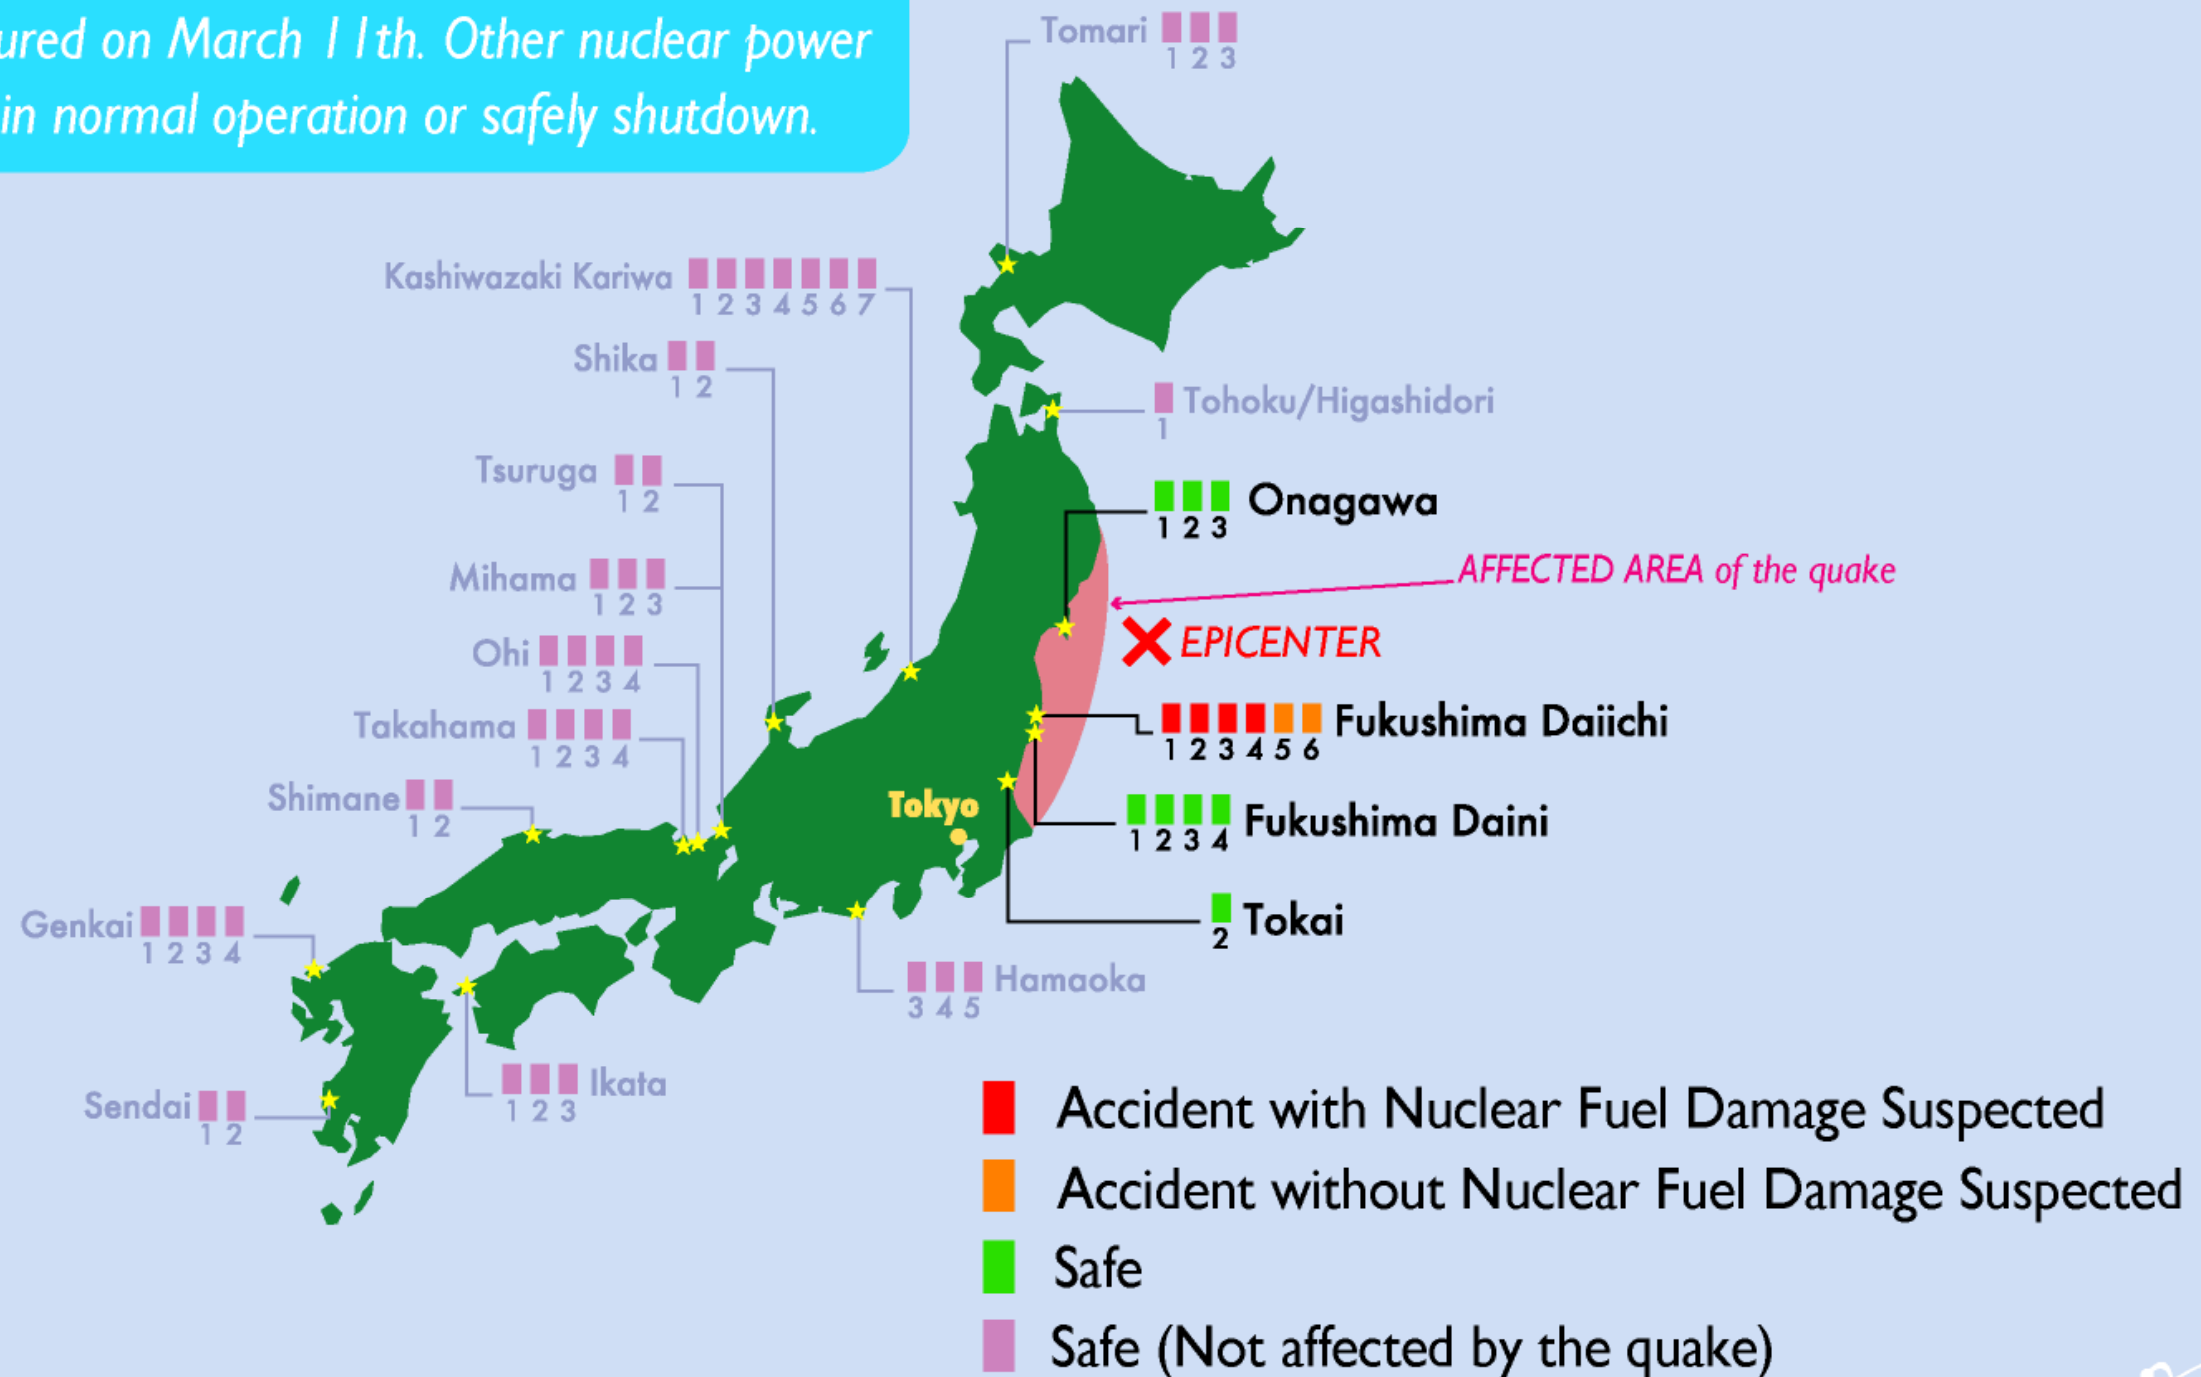
Status of the Nuclear Power Plants after the Earthquake

The accident that brings environmental impact is going on at several units in Fukushima Daiichi nuclear power Station after the earthquake occurred on March 11th. Other nuclear power plants in Japan are in normal operation or safely shutdown.
