Status of nuclear power plants in Fukushima as of 10:00 March 28 (Estimated by JAIF)

Parameters in the Table

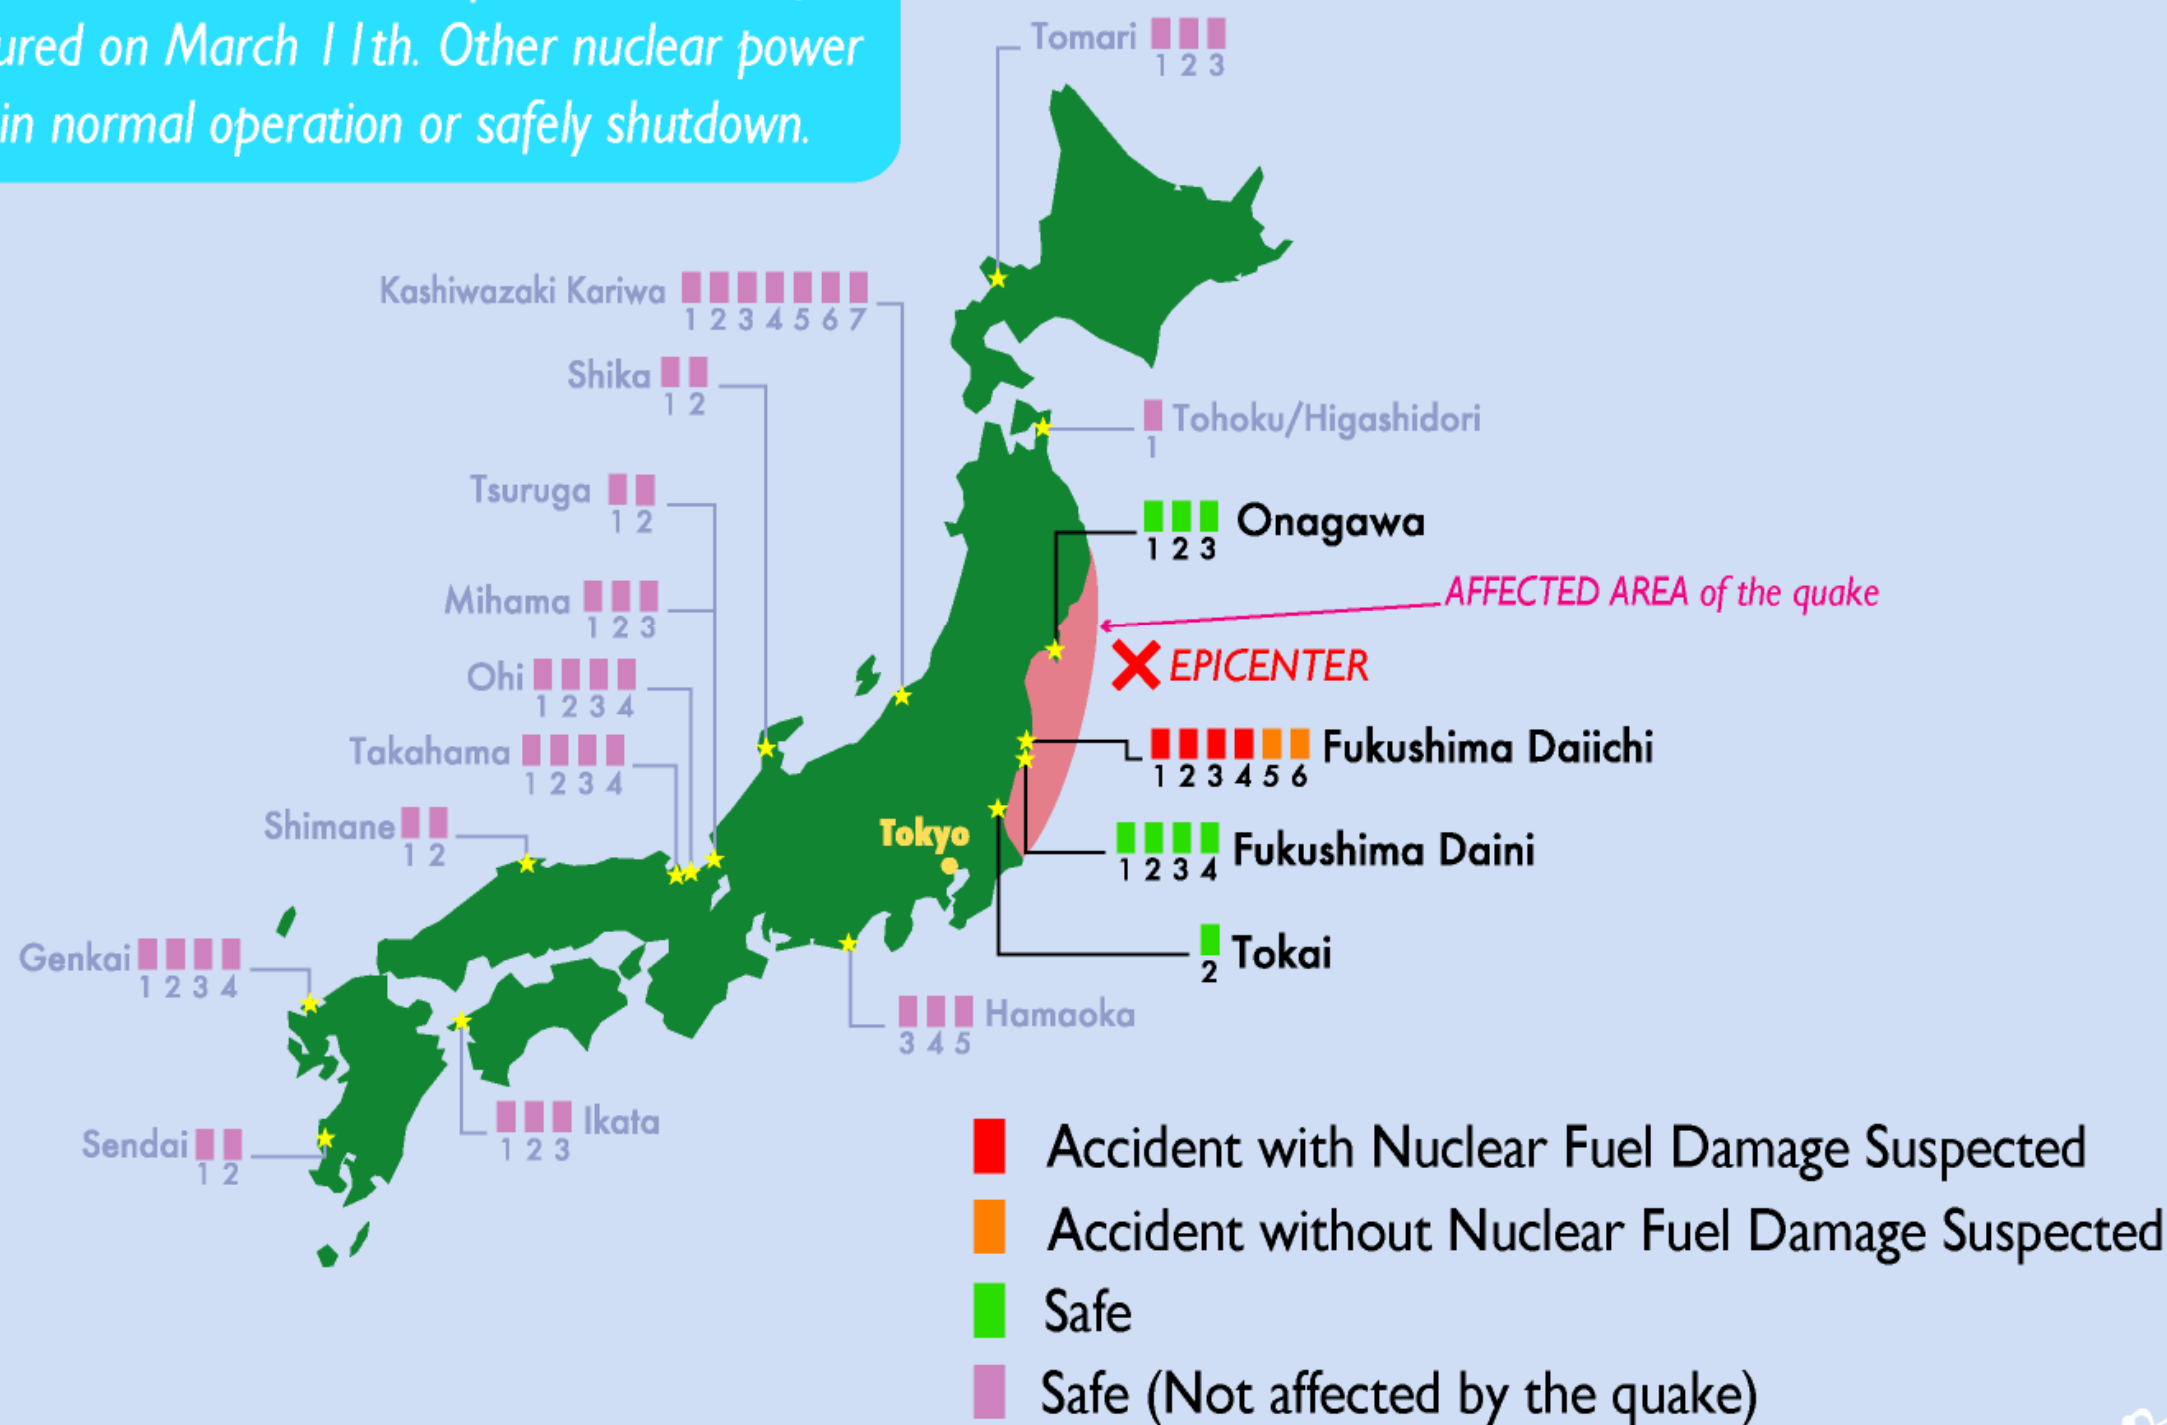
Status of the Nuclear Power Plants after the Earthquake

The accident that brings environmental impact is going on at several units in Fukushima Daiichi nuclear power Station after the earthquake occurred on March 11th. Other nuclear power plants in Japan are in normal operation or safely shutdown.
