Status of nuclear power plants in Fukushima as of 20:00 March 28 (Estimated by JAIF)

JAIF picks up these parameters to evaluate safety condition of the nuclear plants during this accident from the view point of the principles of nuclear power plant safety, which are "Shutdown", "Cooling" and "Containment". Then we create the chart. The following diagram is to show the correspondence relation of these parameters in the table to nuclear power plant safety.

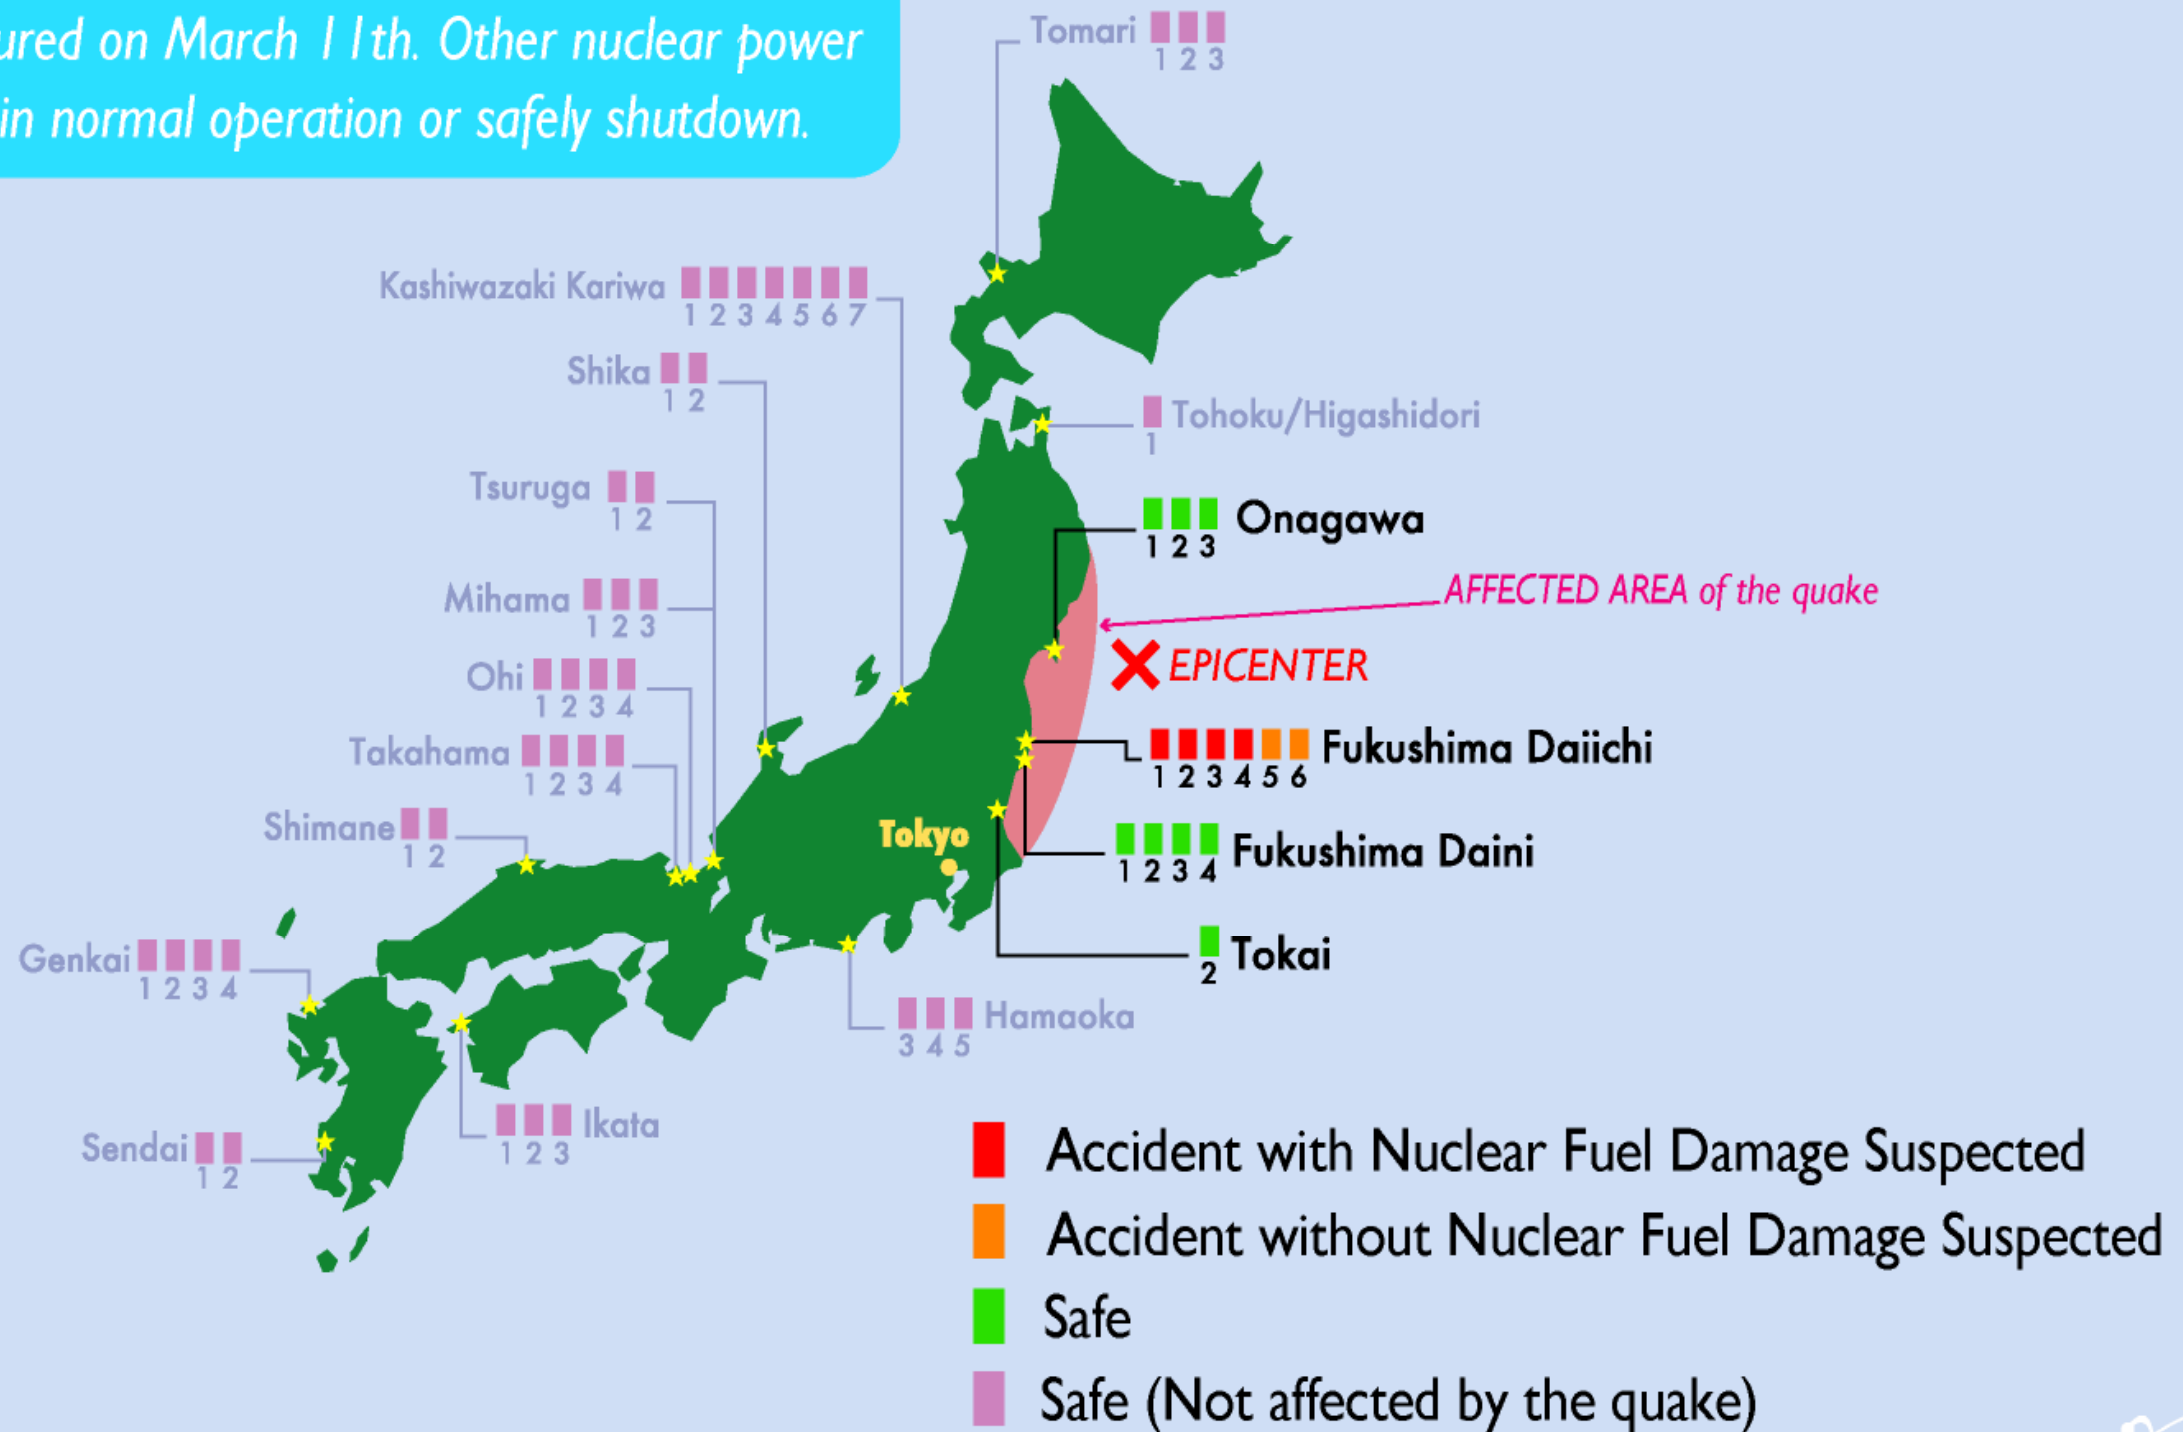
Status of the Nuclear Power Plants after the Earthquake

The accident that brings environmental impact is going on at several units in Fukushima Daiichi nuclear power Station after the earthquake occurred on March 11th. Other nuclear power plants in Japan are in normal operation or safely shutdown.
