Information on Status of Nuclear Power Plants in Fukushima

Japan Atomic Industrial Forum, Inc.

Status of nuclear power plants in Fukushima as of 16:00 March 31 (Estimated by JAIF)

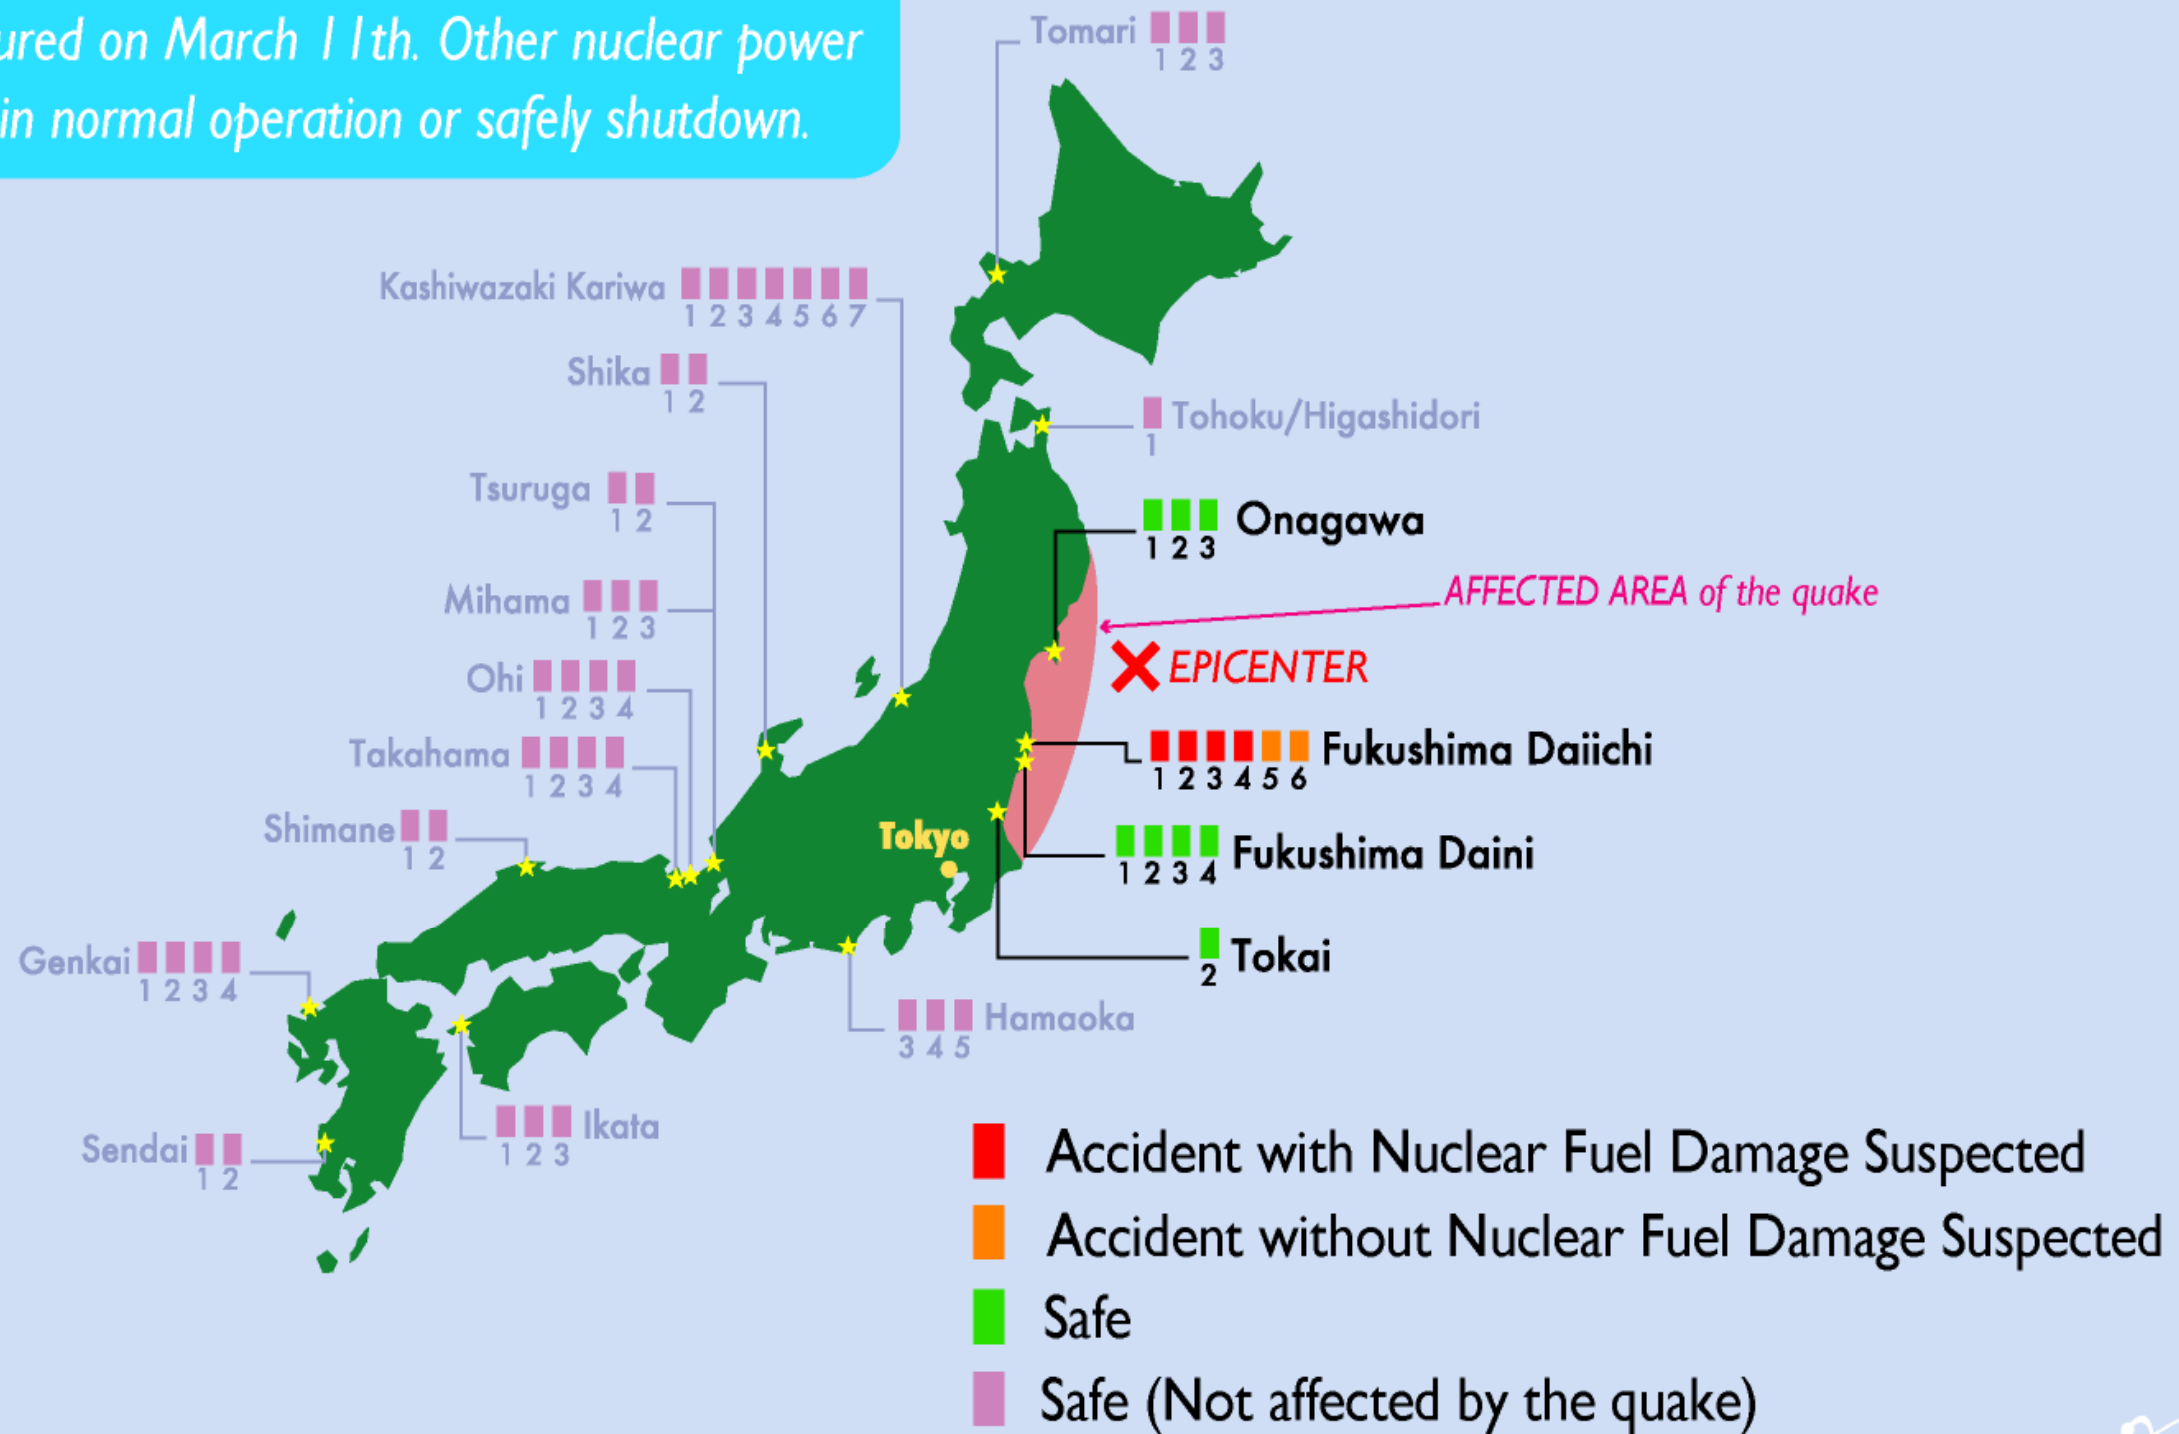
Status of the Nuclear Power Plants after the Earthquake

The accident that brings environmental impact is going on at several units in Fukushima Daiichi nuclear power Station after the earthquake occurred on March 11th. Other nuclear power plants in Japan are in normal operation or safely shutdown.
