Information on Status of Nuclear Power Plants in Fukushima

Japan Atomic Industrial Forum, Inc.

Status of nuclear power plants in Fukushima as of 18:00, April 2nd (Estimated by JAIF)

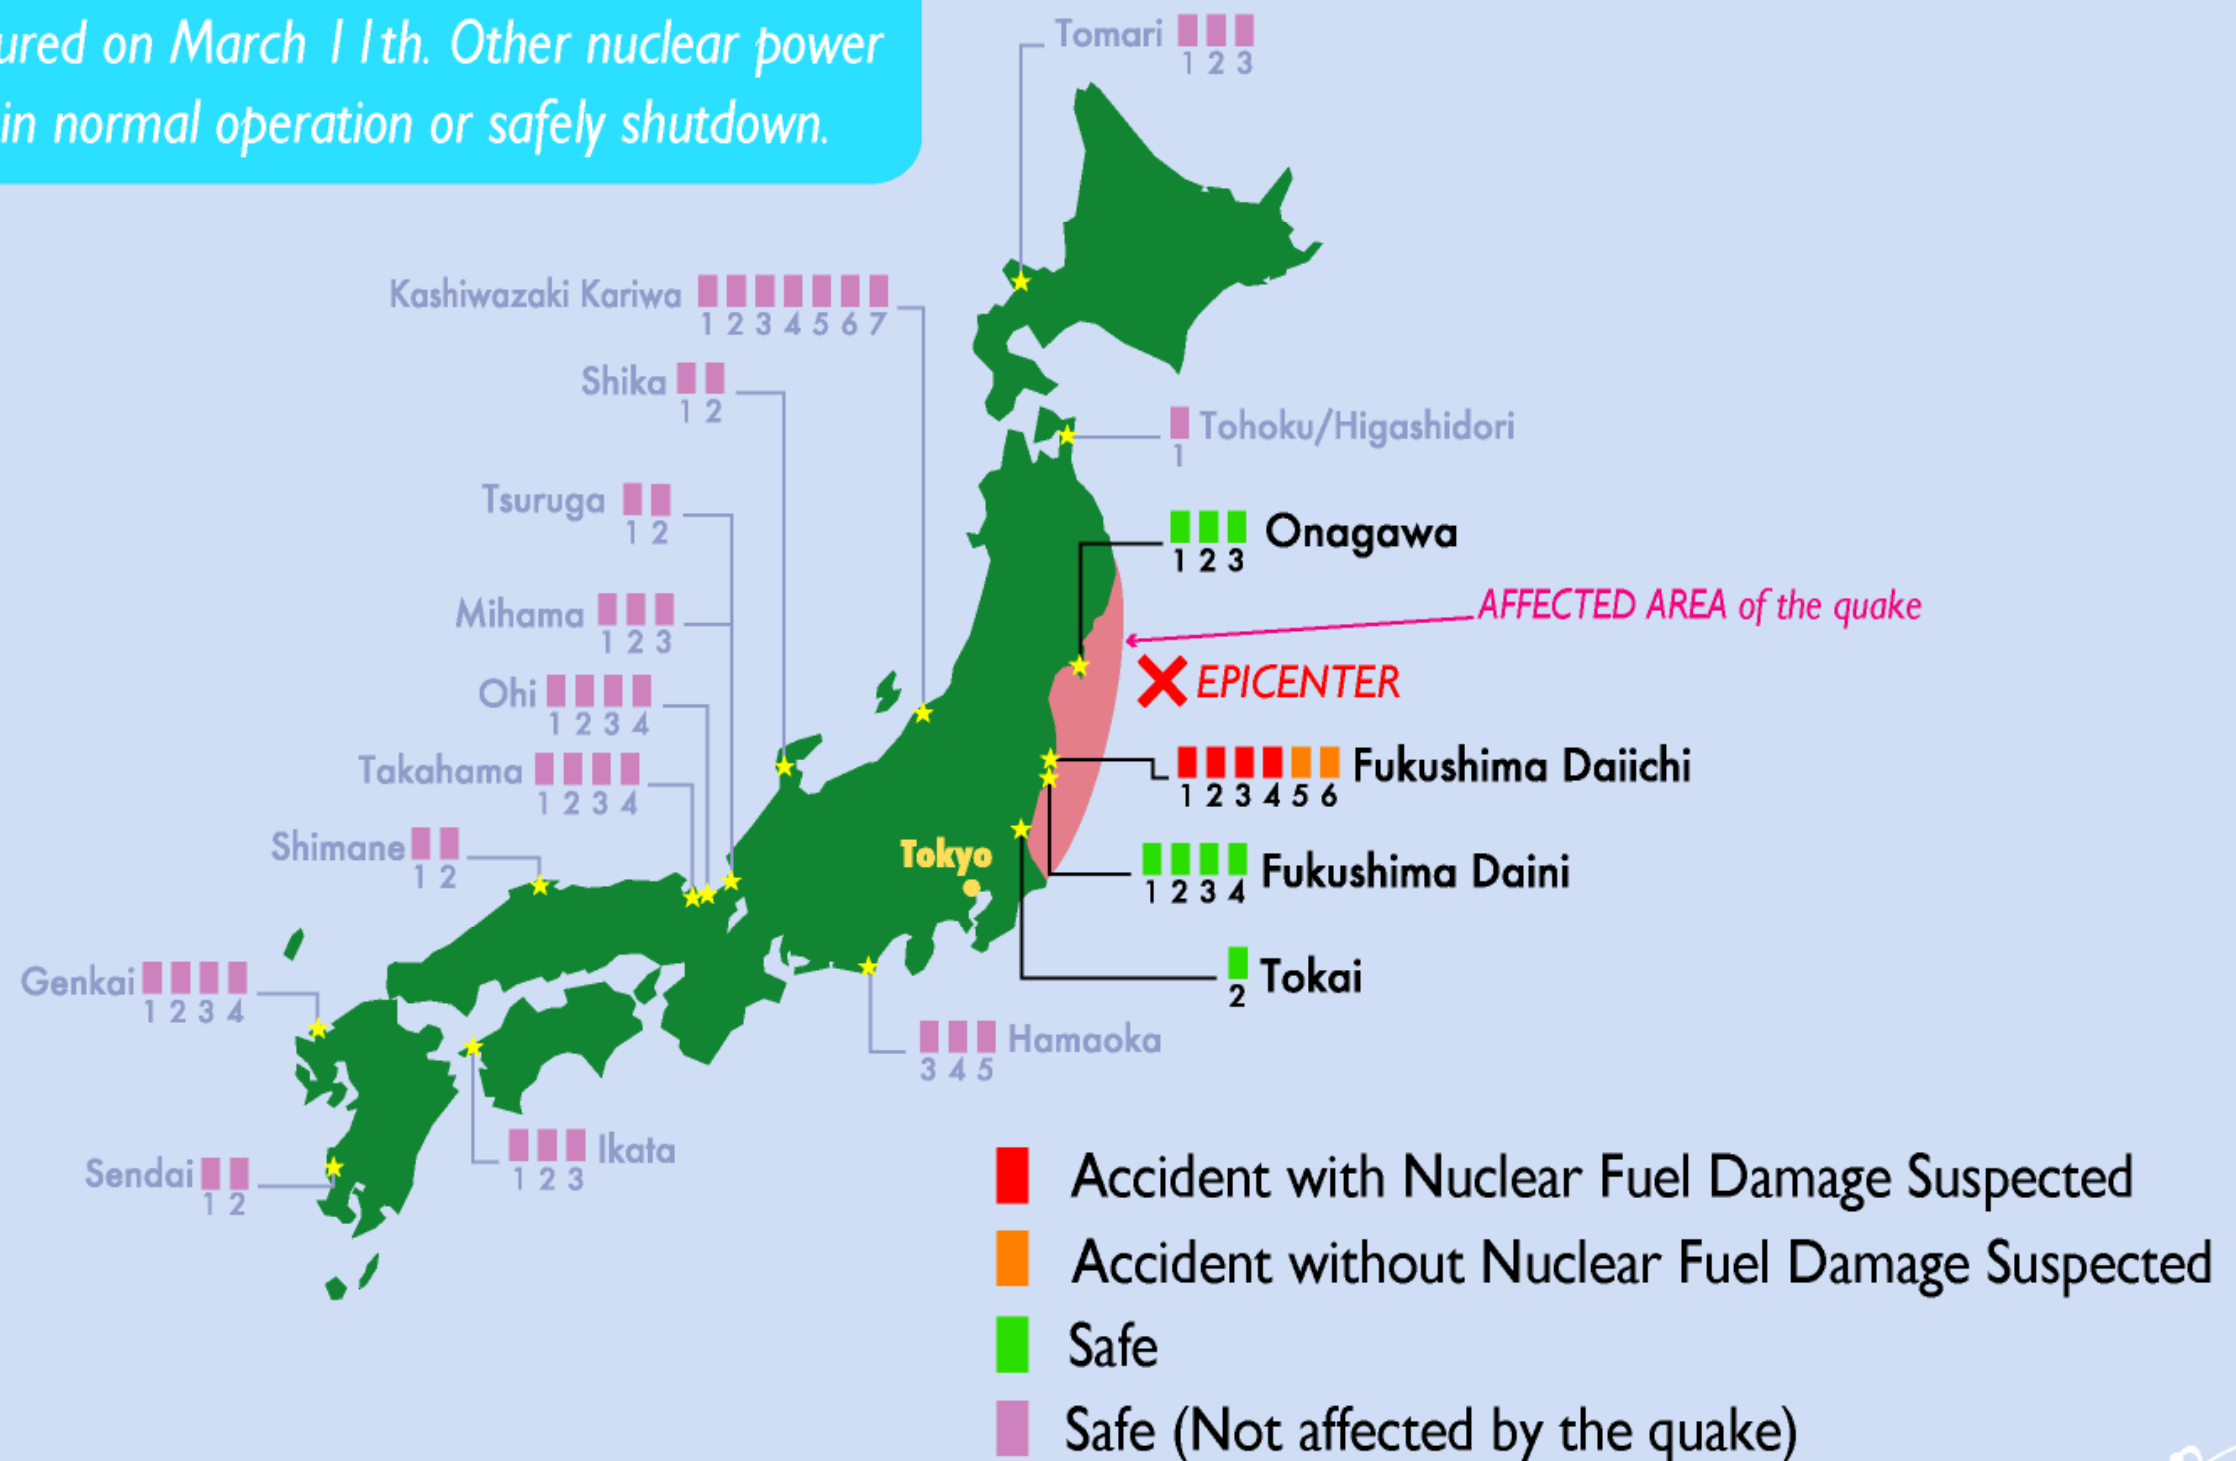
Status of the Nuclear Power Plants after the Earthquake

The accident that brings environmental impact is going on at several units in Fukushima Daiichi nuclear power Station after the earthquake occurred on March 11th. Other nuclear power plants in Japan are in normal operation or safely shutdown.
