Information on Status of Nuclear Power Plants in Fukushima

Japan Atomic Industrial Forum, Inc.

Status of nuclear power plants in Fukushima as of 16:00, April 4th (Estimated by JAIF)

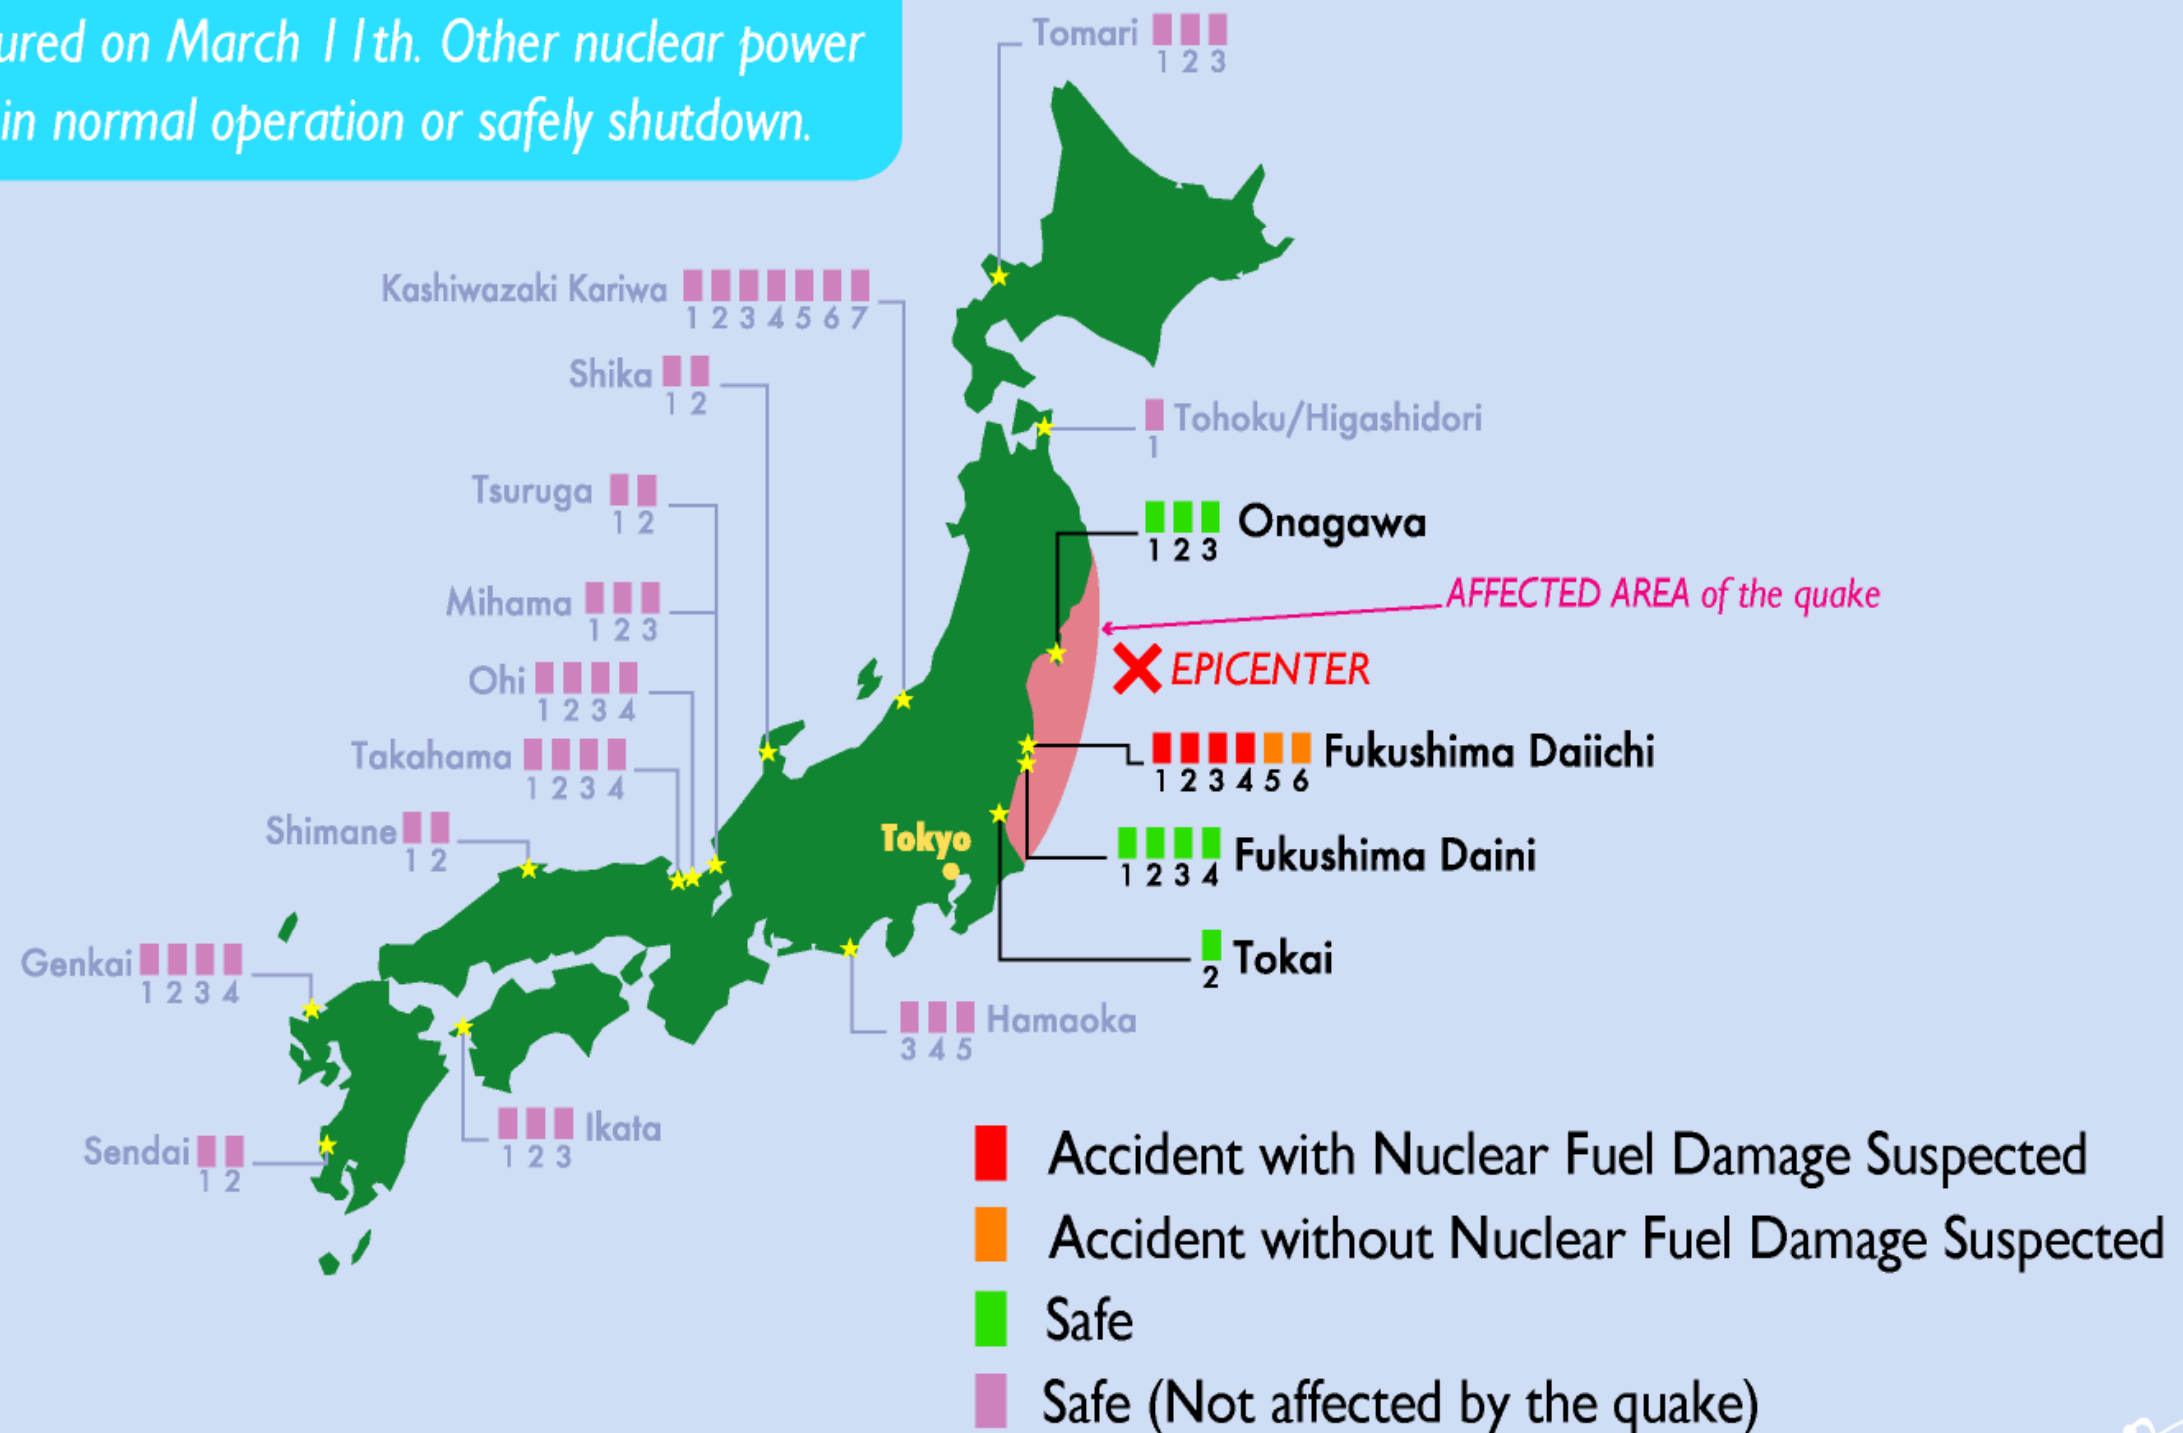
Status of the Nuclear Power Plants after the Earthquake

The accident that brings environmental impact is going on at several units in Fukushima Daiichi nuclear power Station after the earthquake occurred on March 11th. Other nuclear power plants in Japan are in normal operation or safely shutdown.
