Information on Status of Nuclear Power Plants in Fukushima

Japan Atomic Industrial Forum, Inc.

Status of nuclear power plants in Fukushima as of 10:00, April 7th (Estimated by JAIF)

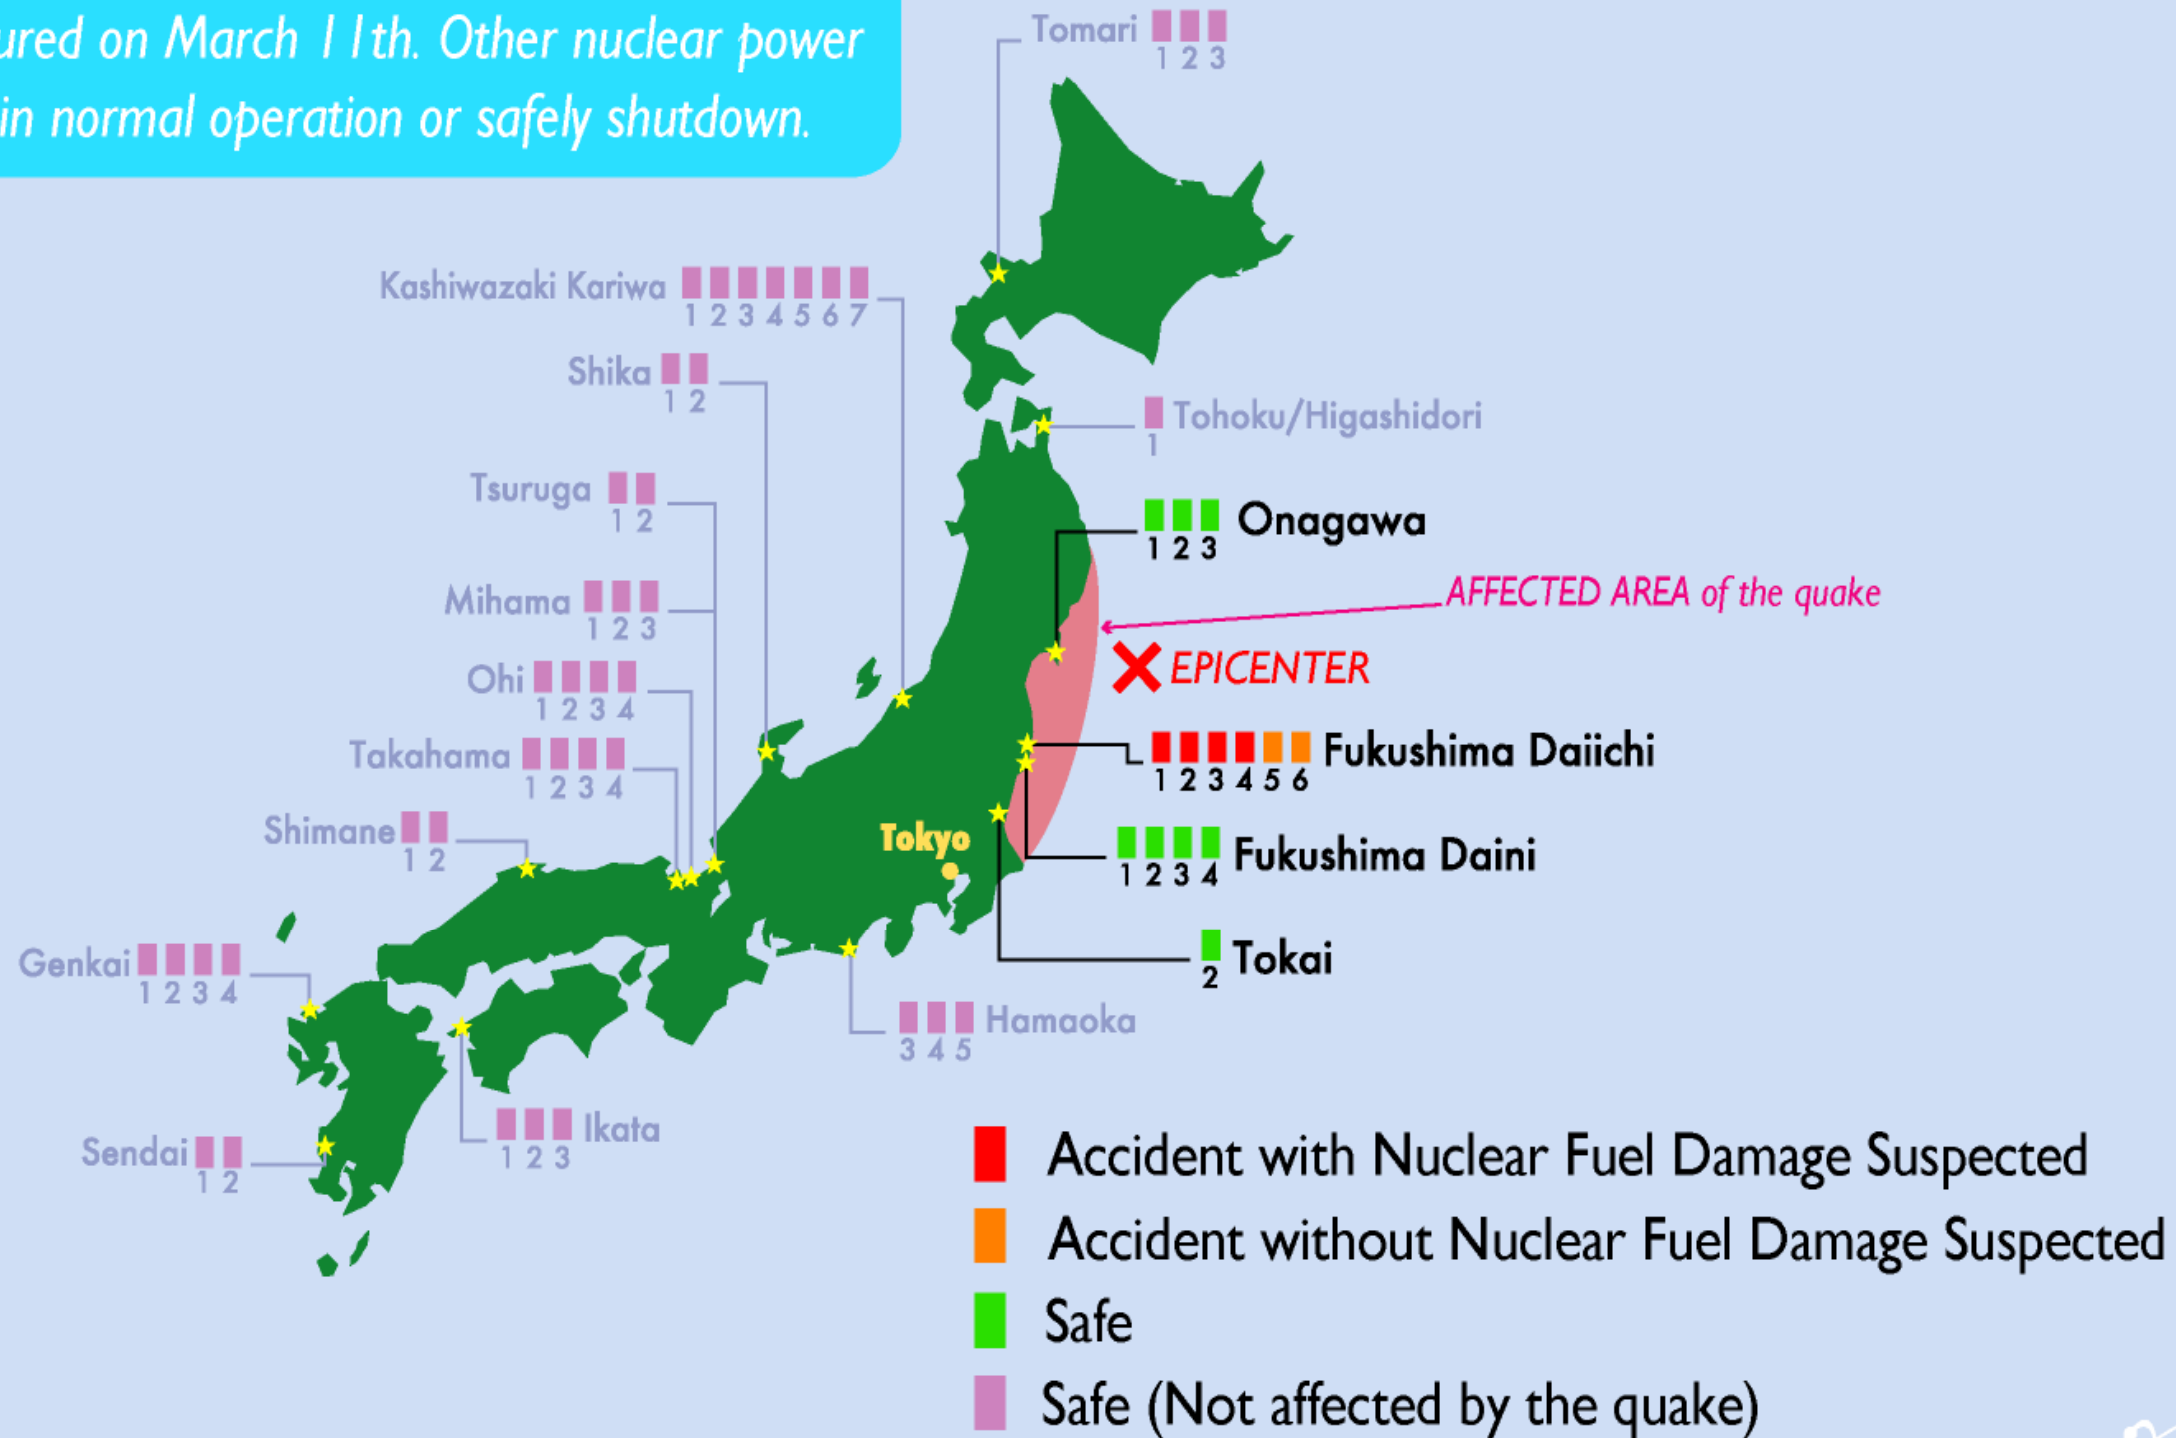
Status of the Nuclear Power Plants after the Earthquake

The accident that brings environmental impact is going on at several units in Fukushima Daiichi nuclear power Station after the earthquake occurred on March 11th. Other nuclear power plants in Japan are in normal operation or safely shutdown.
