Information on Status of Nuclear Power Plants in Fukushima

Japan Atomic Industrial Forum, Inc.

Status of nuclear power plants in Fukushima as of 16:00, April 7th (Estimated by JAIF)

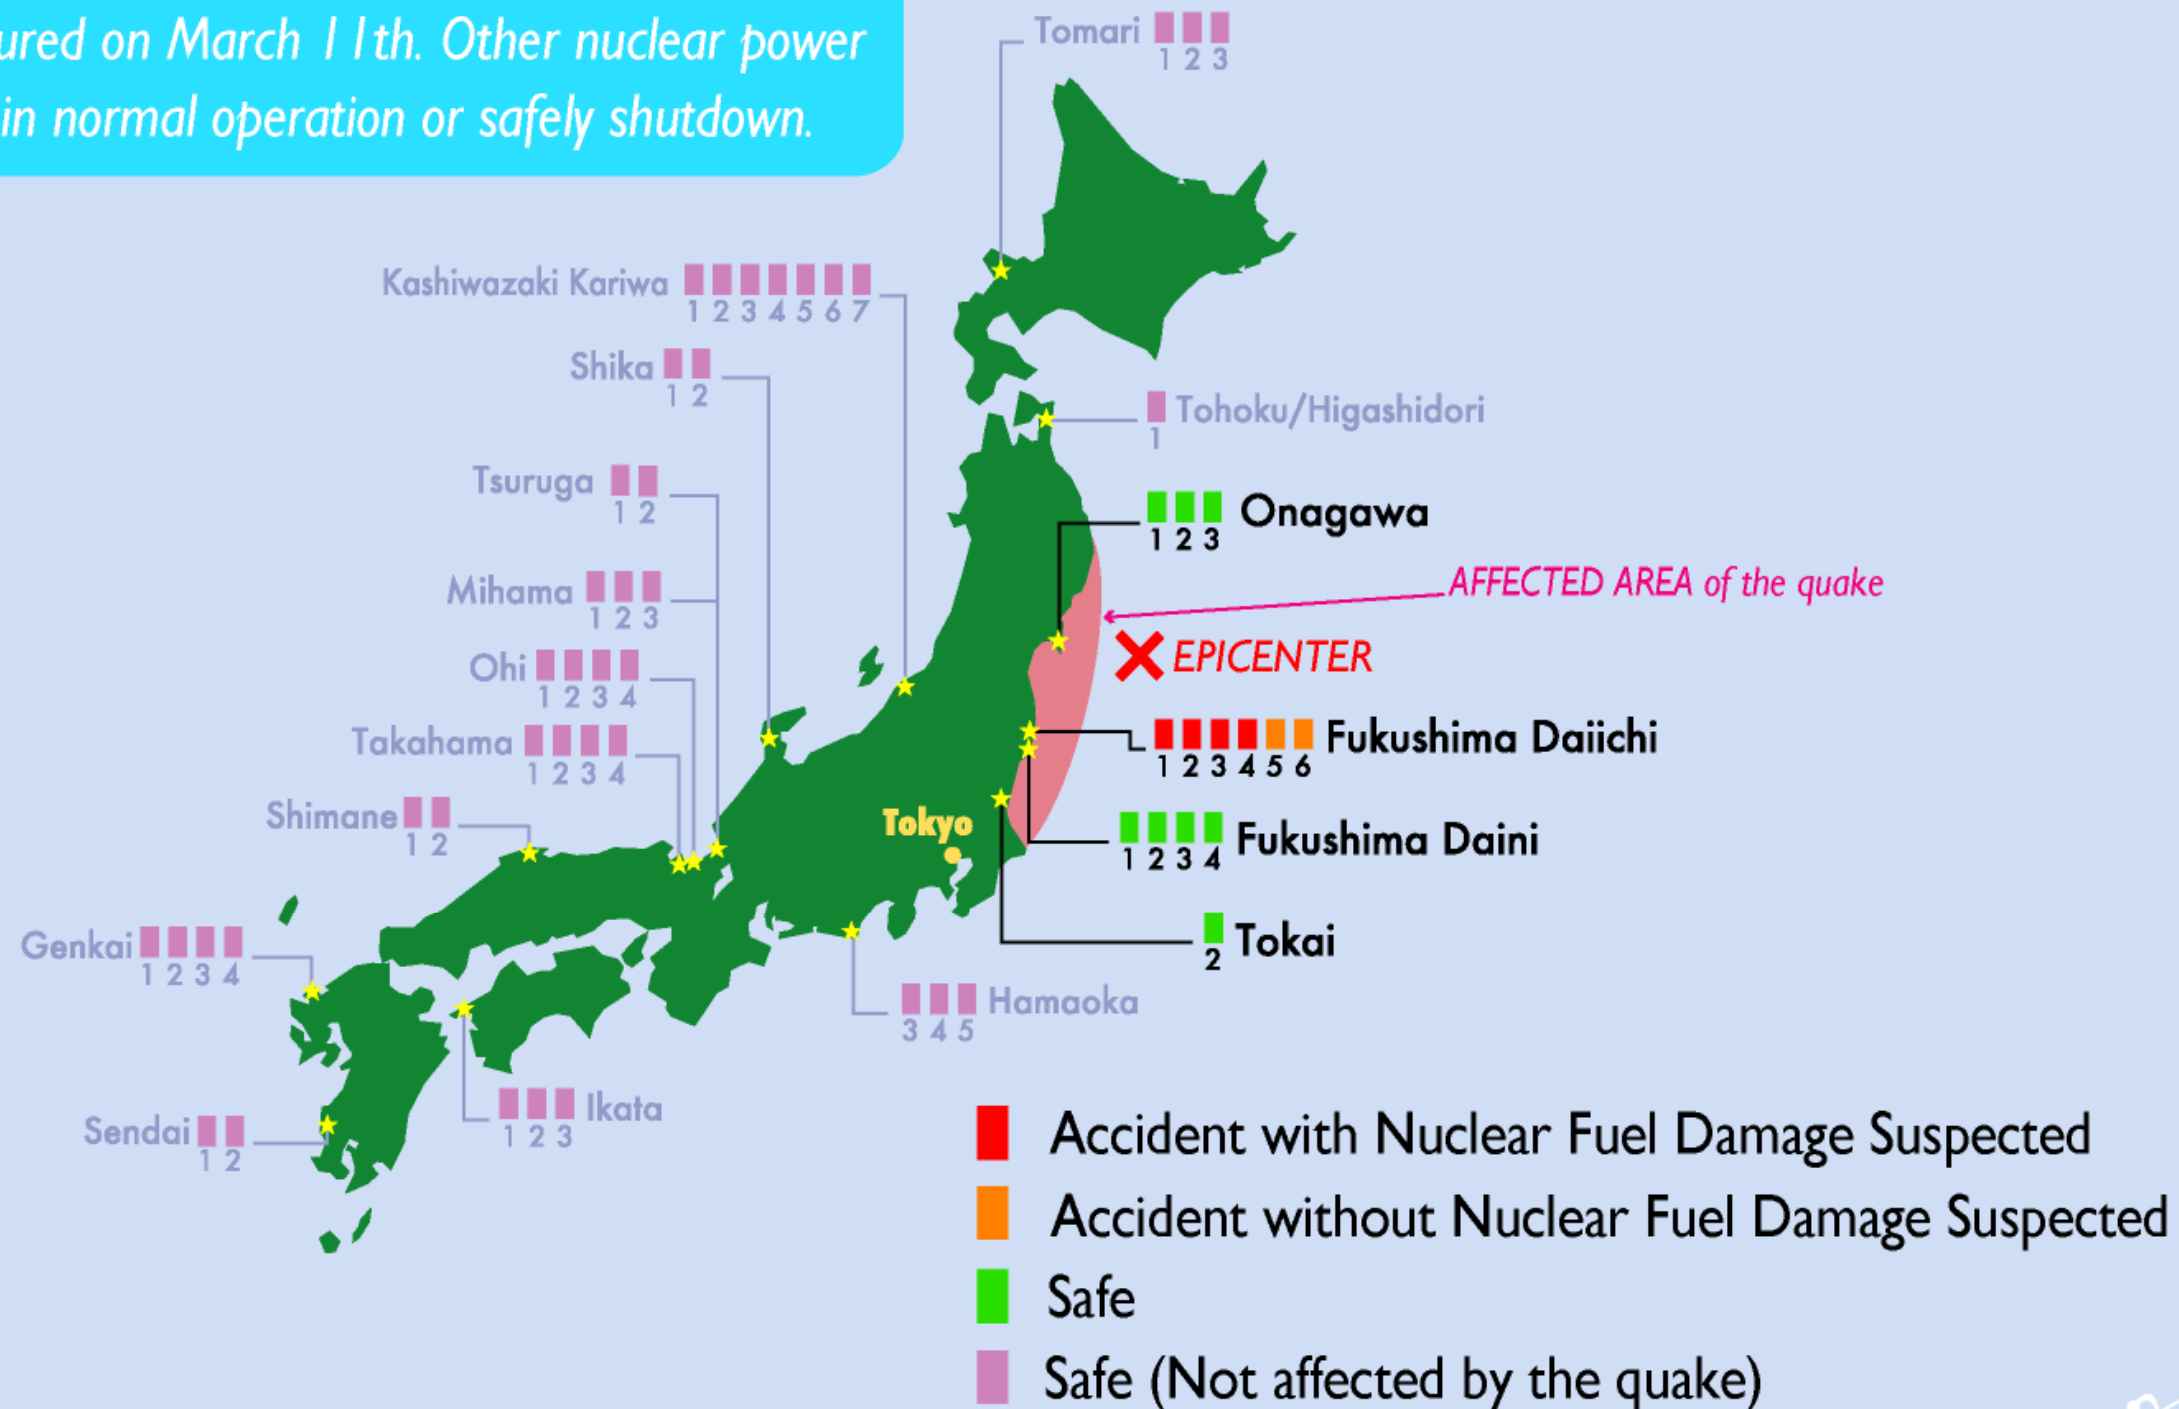
Status of the Nuclear Power Plants after the Earthquake

The accident that brings environmental impact is going on at several units in Fukushima Daiichi nuclear power Station after the earthquake occurred on March 11th. Other nuclear power plants in Japan are in normal operation or safely shutdown.
