Information on Status of Nuclear Power Plants in Fukushima

Japan Atomic Industrial Forum, Inc.

Status of nuclear power plants in Fukushima as of 10:00, April 9th (Estimated by JAIF)

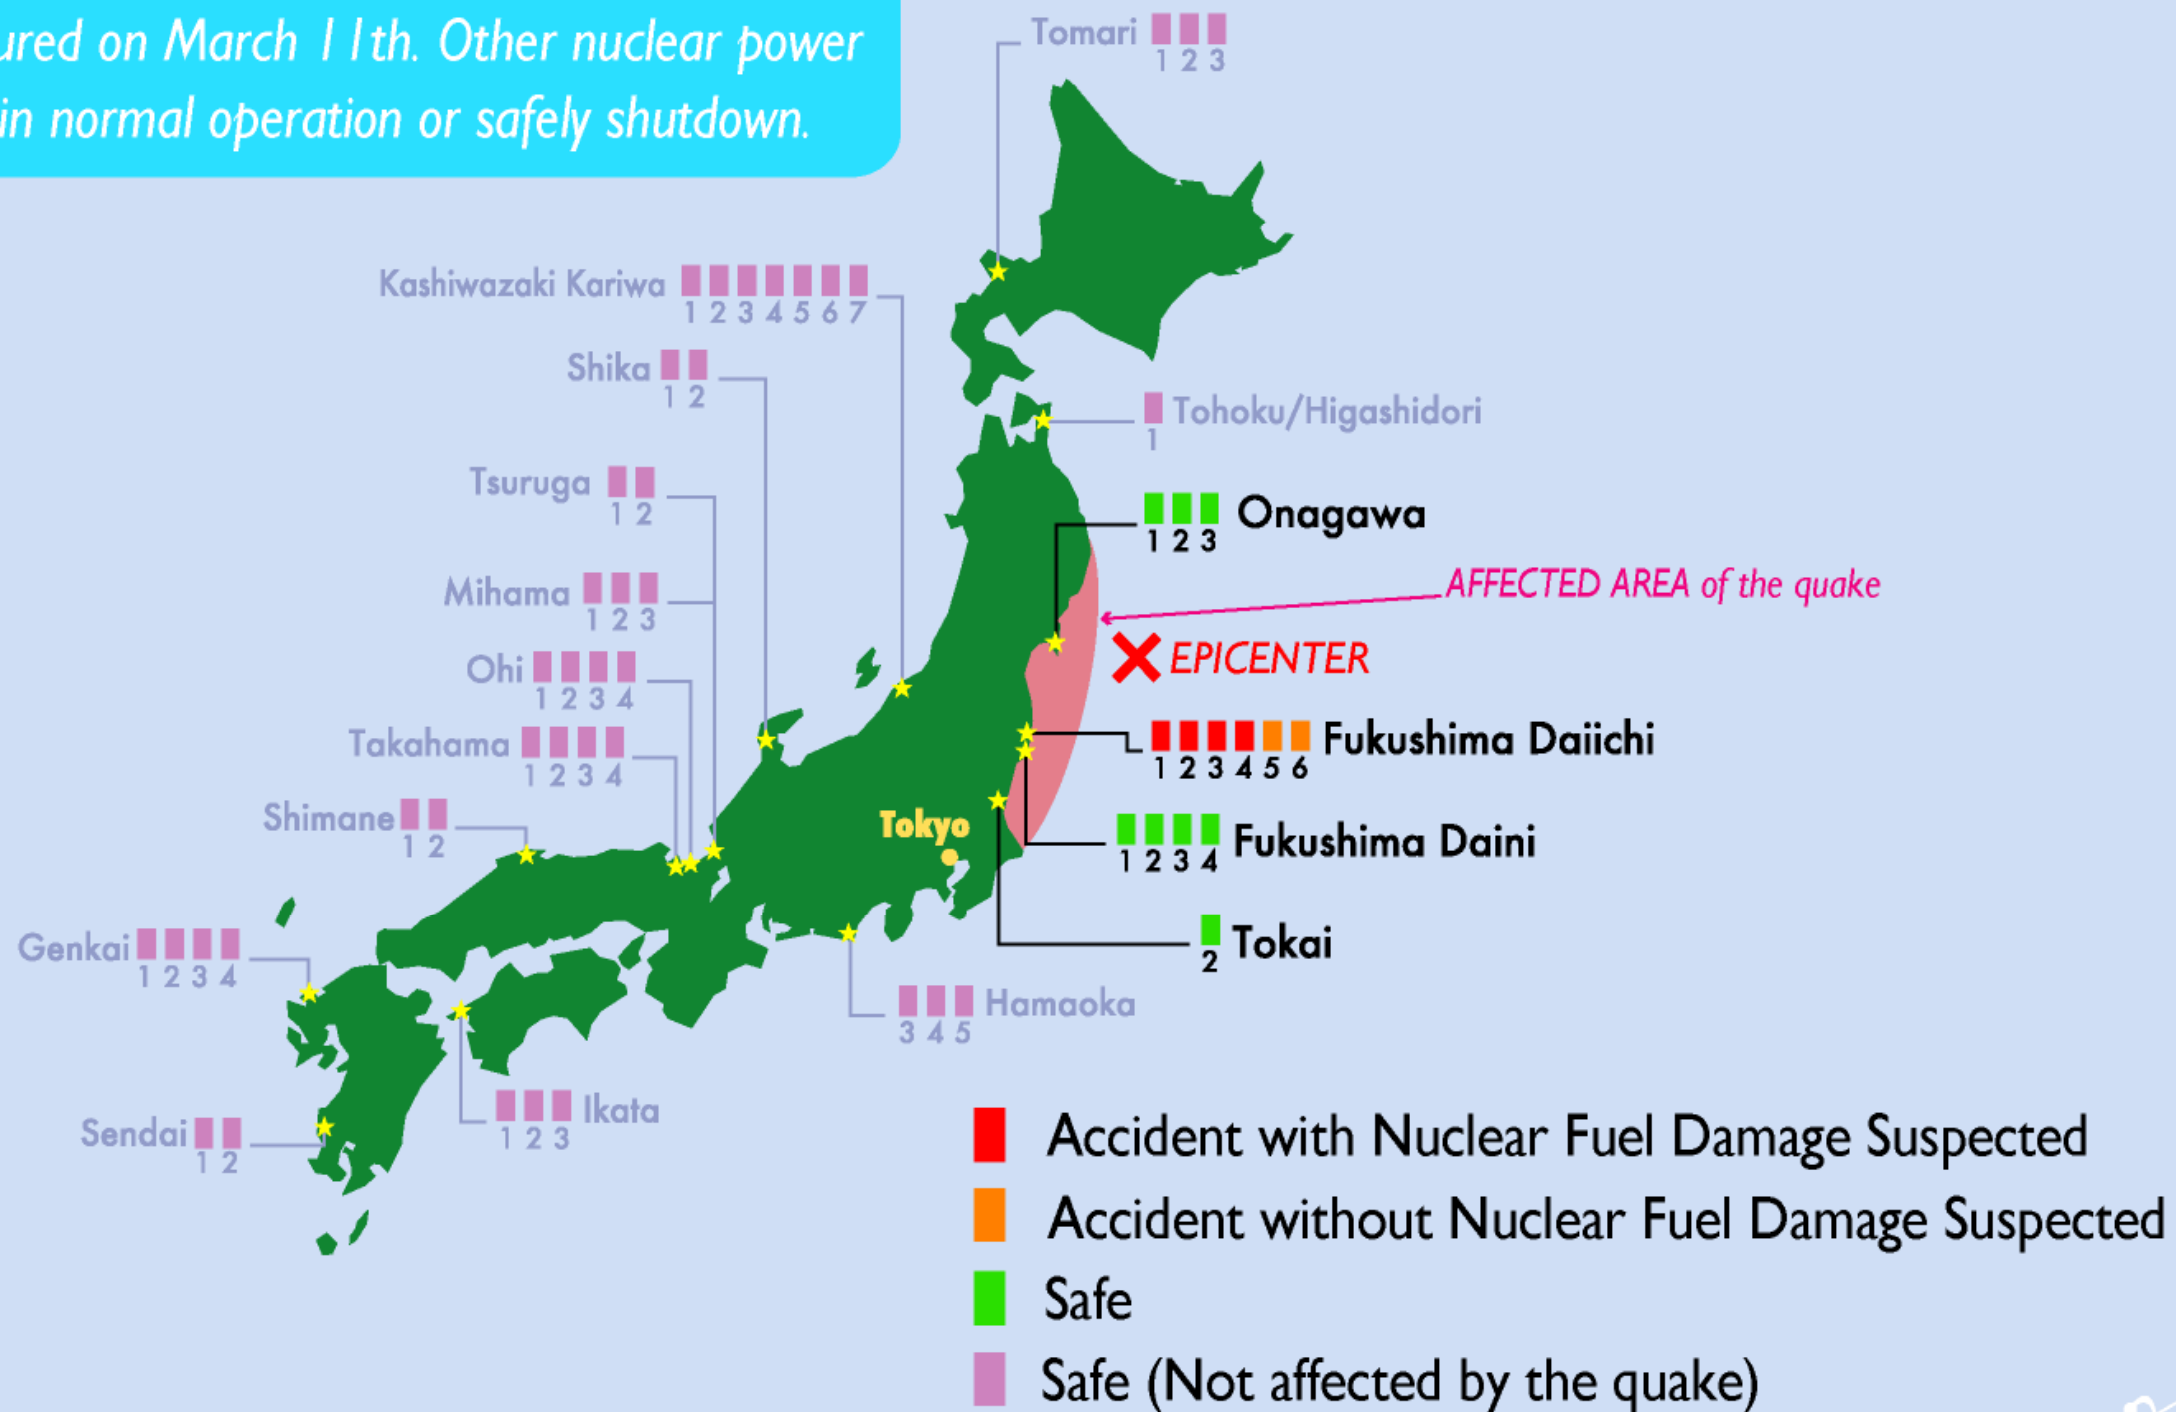
Status of the Nuclear Power Plants after the Earthquake

The accident that brings environmental impact is going on at several units in Fukushima Daiichi nuclear power Station after the earthquake occurred on March 11th. Other nuclear power plants in Japan are in normal operation or safely shutdown.
