Information on Status of Nuclear Power Plants in Fukushima

Japan Atomic Industrial Forum, Inc.

Status of nuclear power plants in Fukushima as of 16:00, April 12th (Estimated by JAIF)

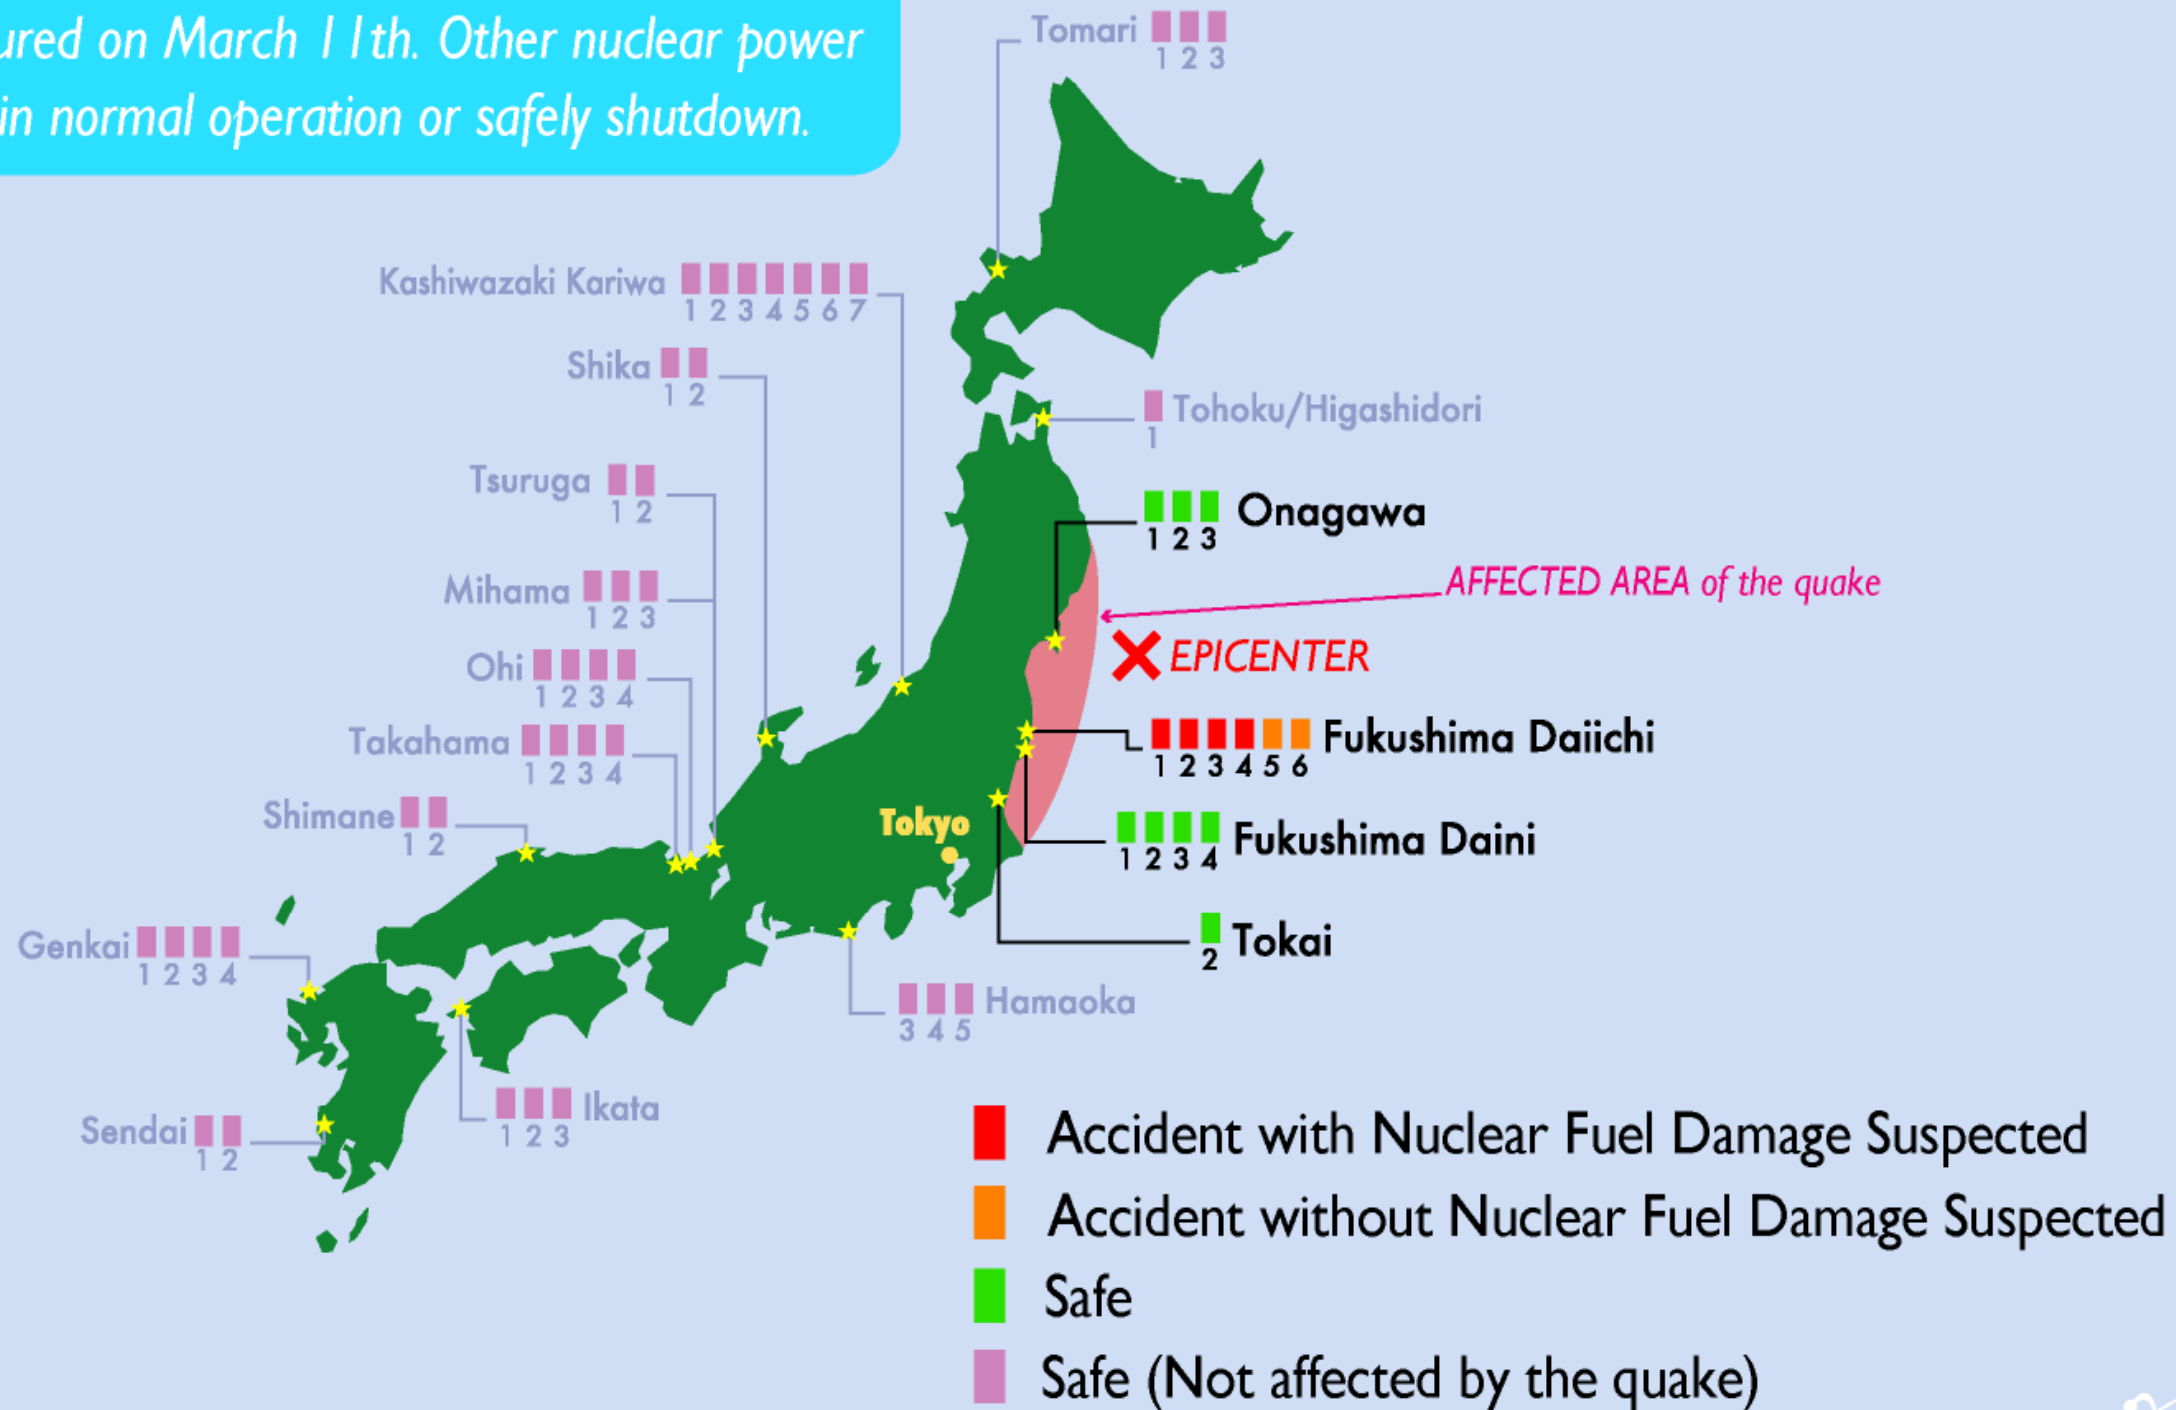
Status of the Nuclear Power Plants after the Earthquake

The accident that brings environmental impact is going on at several units in Fukushima Daiichi nuclear power Station after the earthquake occurred on March 11th. Other nuclear power plants in Japan are in normal operation or safely shutdown.
