Information on Status of Nuclear Power Plants in Fukushima

Japan Atomic Industrial Forum, Inc.

Status of nuclear power plants in Fukushima as of 10:00, April 20th (Estimated by JAIF)

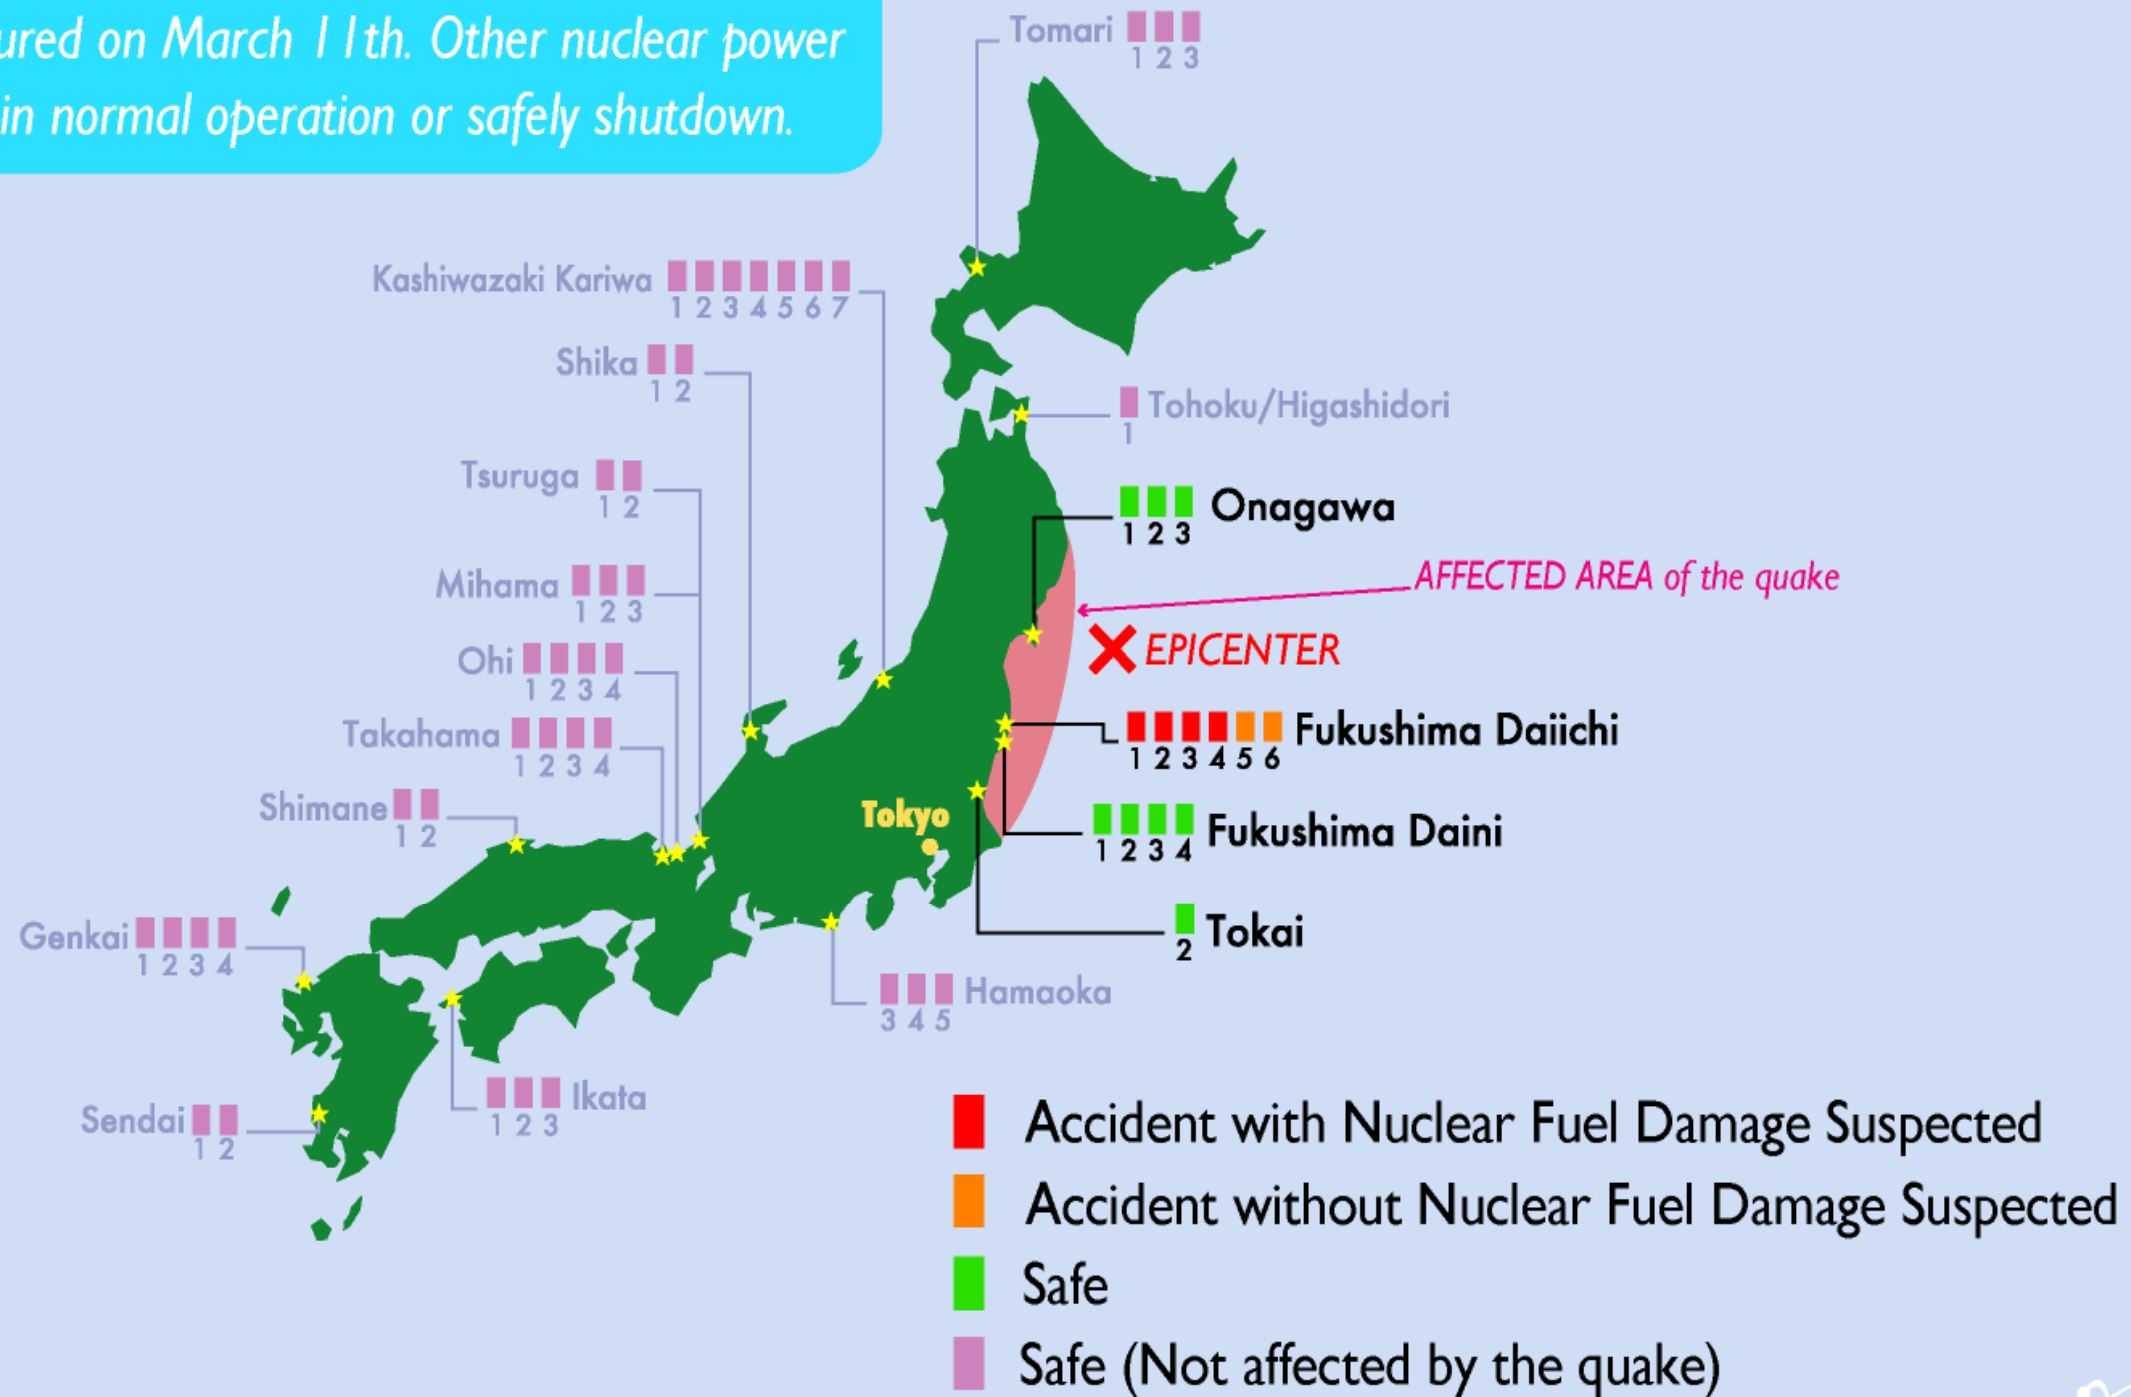
Status of the Nuclear Power Plants after the Earthquake

The accident that brings environmental impact is going on at several units in Fukushima Daiichi nuclear power Station after the earthquake occurred on March 11th. Other nuclear power plants in Japan are in normal operation or safely shutdown.
