# Information on Status of Nuclear Power Plants in Fukushima

Japan Atomic Industrial Forum, Inc.

**Status of nuclear power plants in Fukushima as of 10:00, April 16th (Estimated by JAIF)**

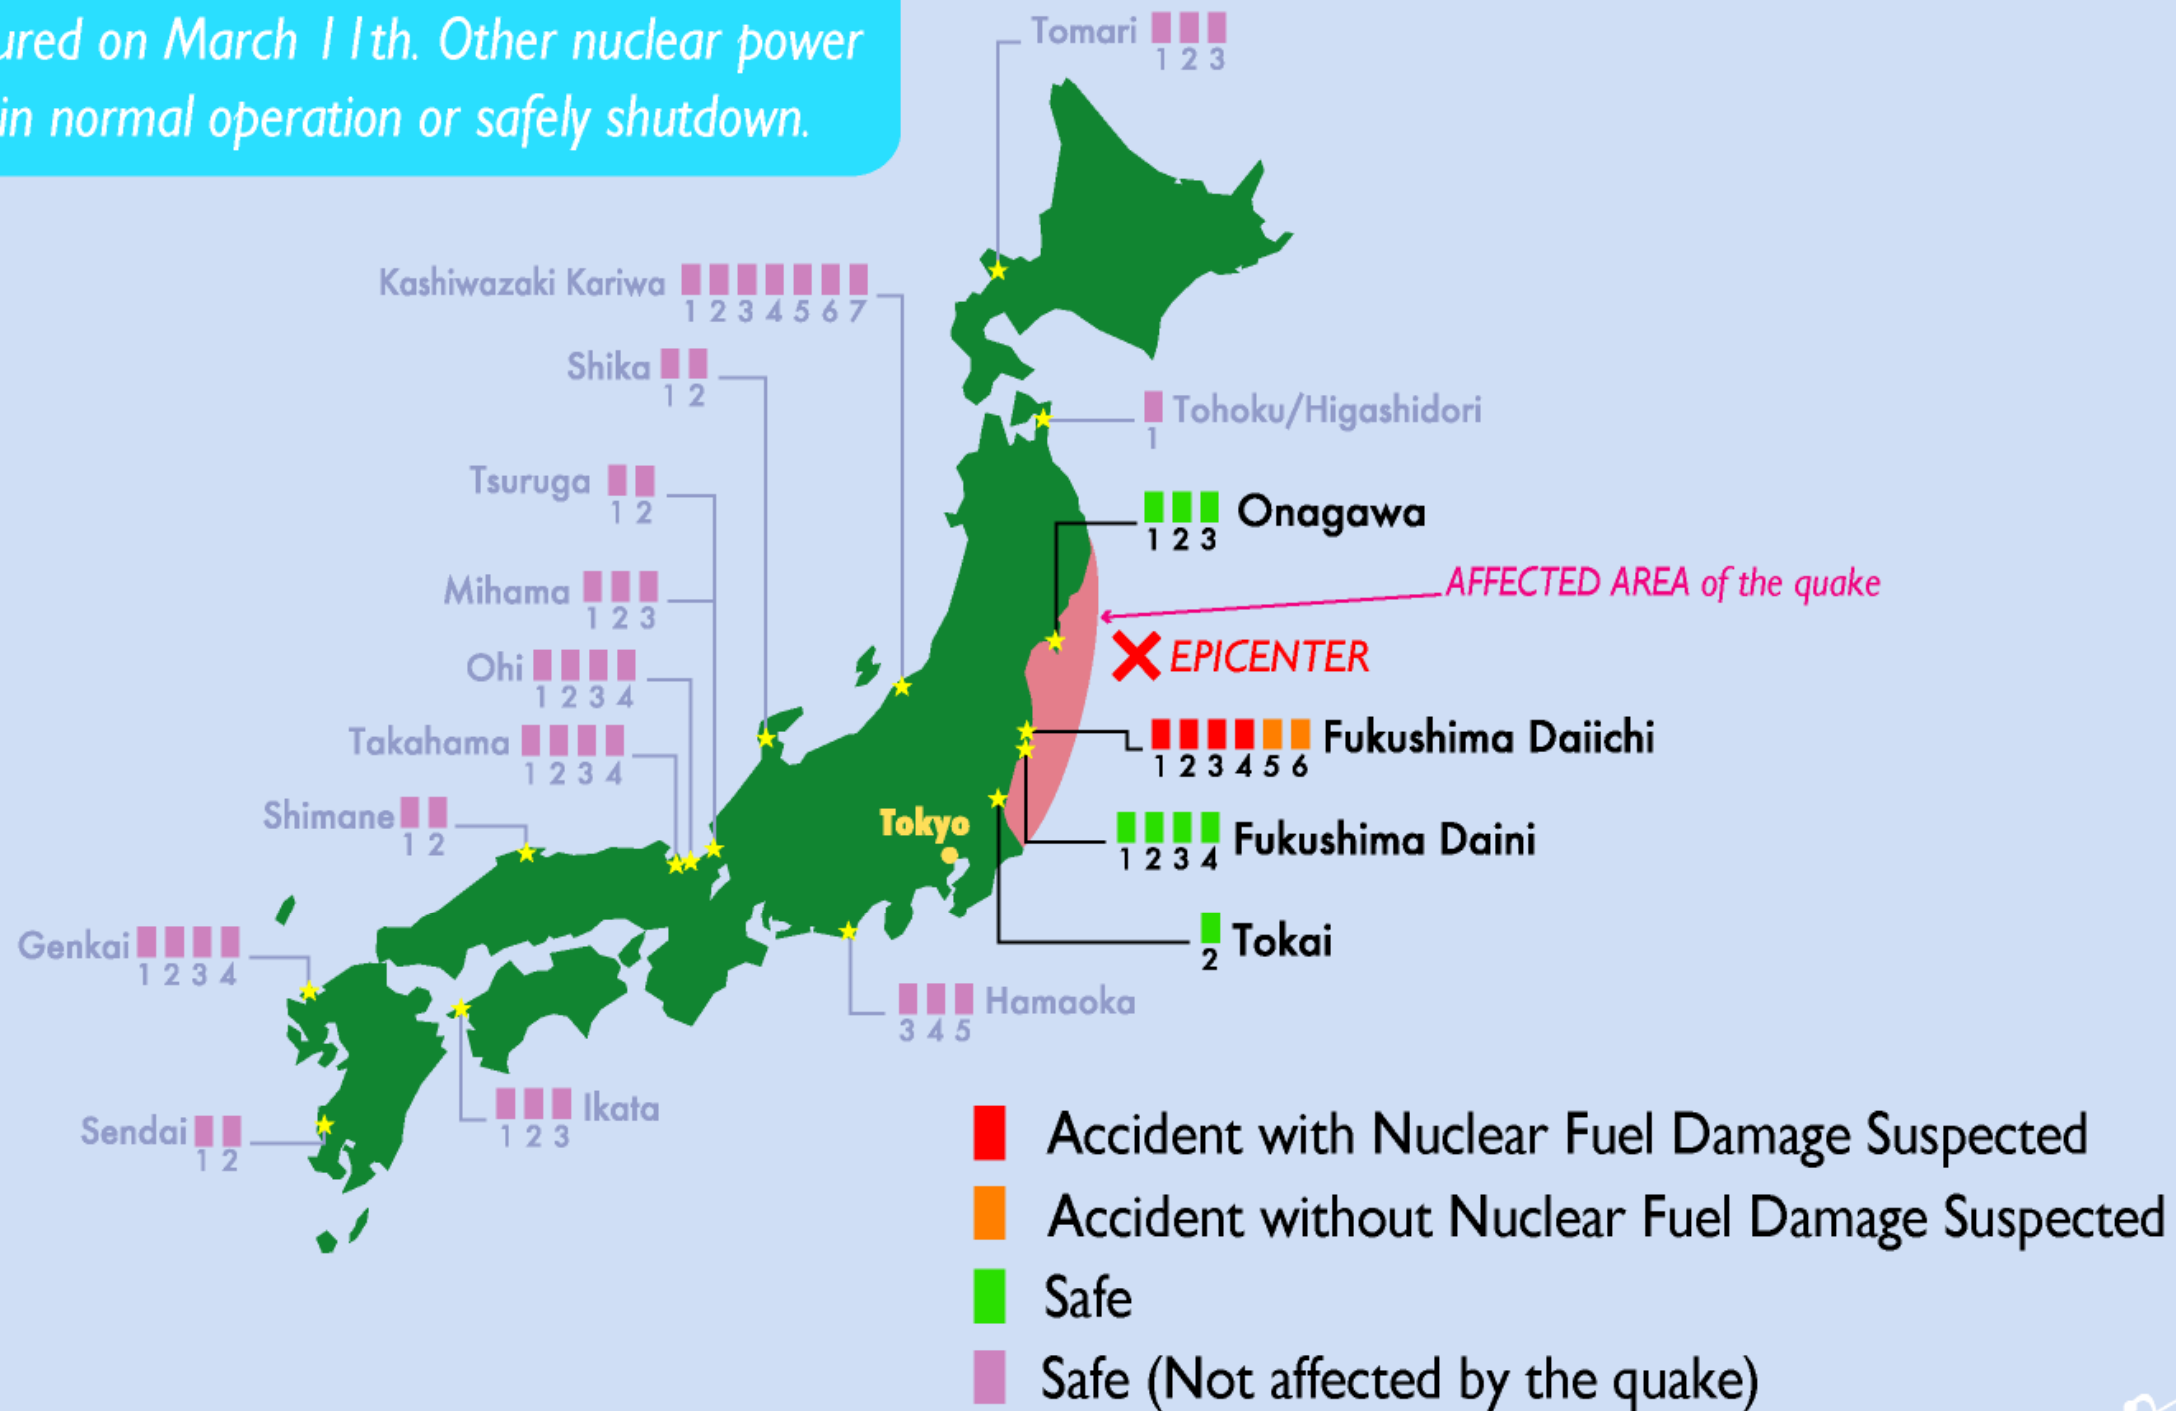
# Status of the Nuclear Power Plants after the Earthquake

The accident that brings environmental impact is going on at several units in Fukushima Daiichi nuclear power Station after the earthquake occurred on March 11th. Other nuclear power plants in Japan are in normal operation or safely shutdown.
