# Information on Status of Nuclear Power Plants in Fukushima

Japan Atomic Industrial Forum, Inc.

**Status of nuclear power plants in Fukushima as of 16:00, April 20th (Estimated by JAIF)**

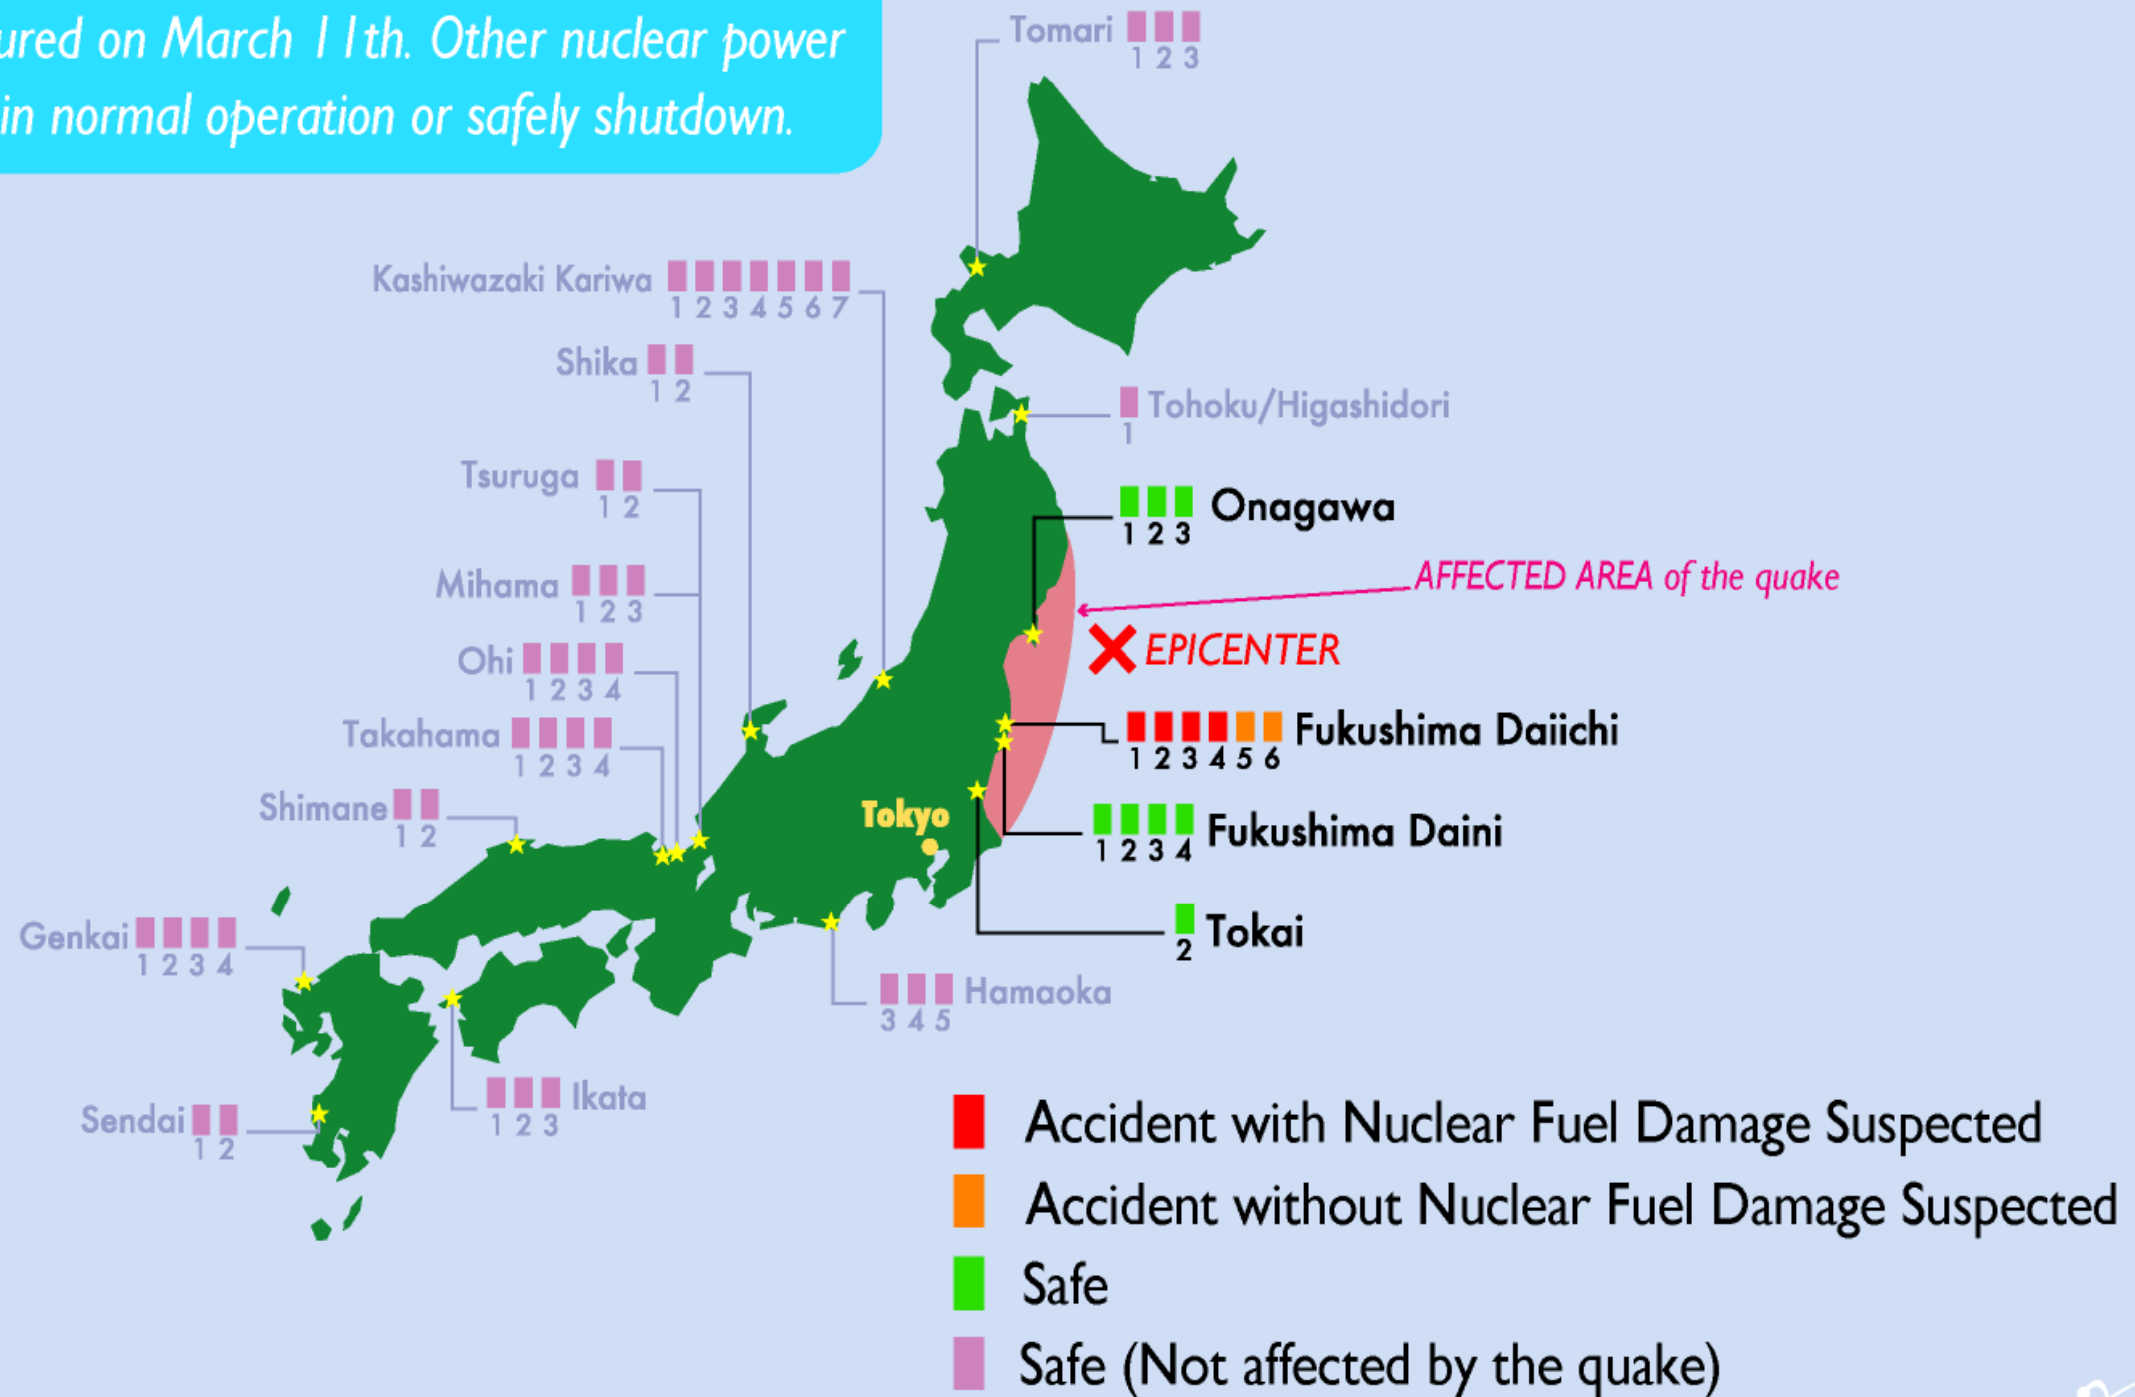
# Status of the Nuclear Power Plants after the Earthquake

The accident that brings environmental impact is going on at several units in Fukushima Daiichi nuclear power Station after the earthquake occurred on March 11th. Other nuclear power plants in Japan are in normal operation or safely shutdown.
