Information on Status of Nuclear Power Plants in Fukushima

Japan Atomic Industrial Forum, Inc.

Status of nuclear power plants in Fukushima as of 12:00, May 12th (Estimated by JAIF)

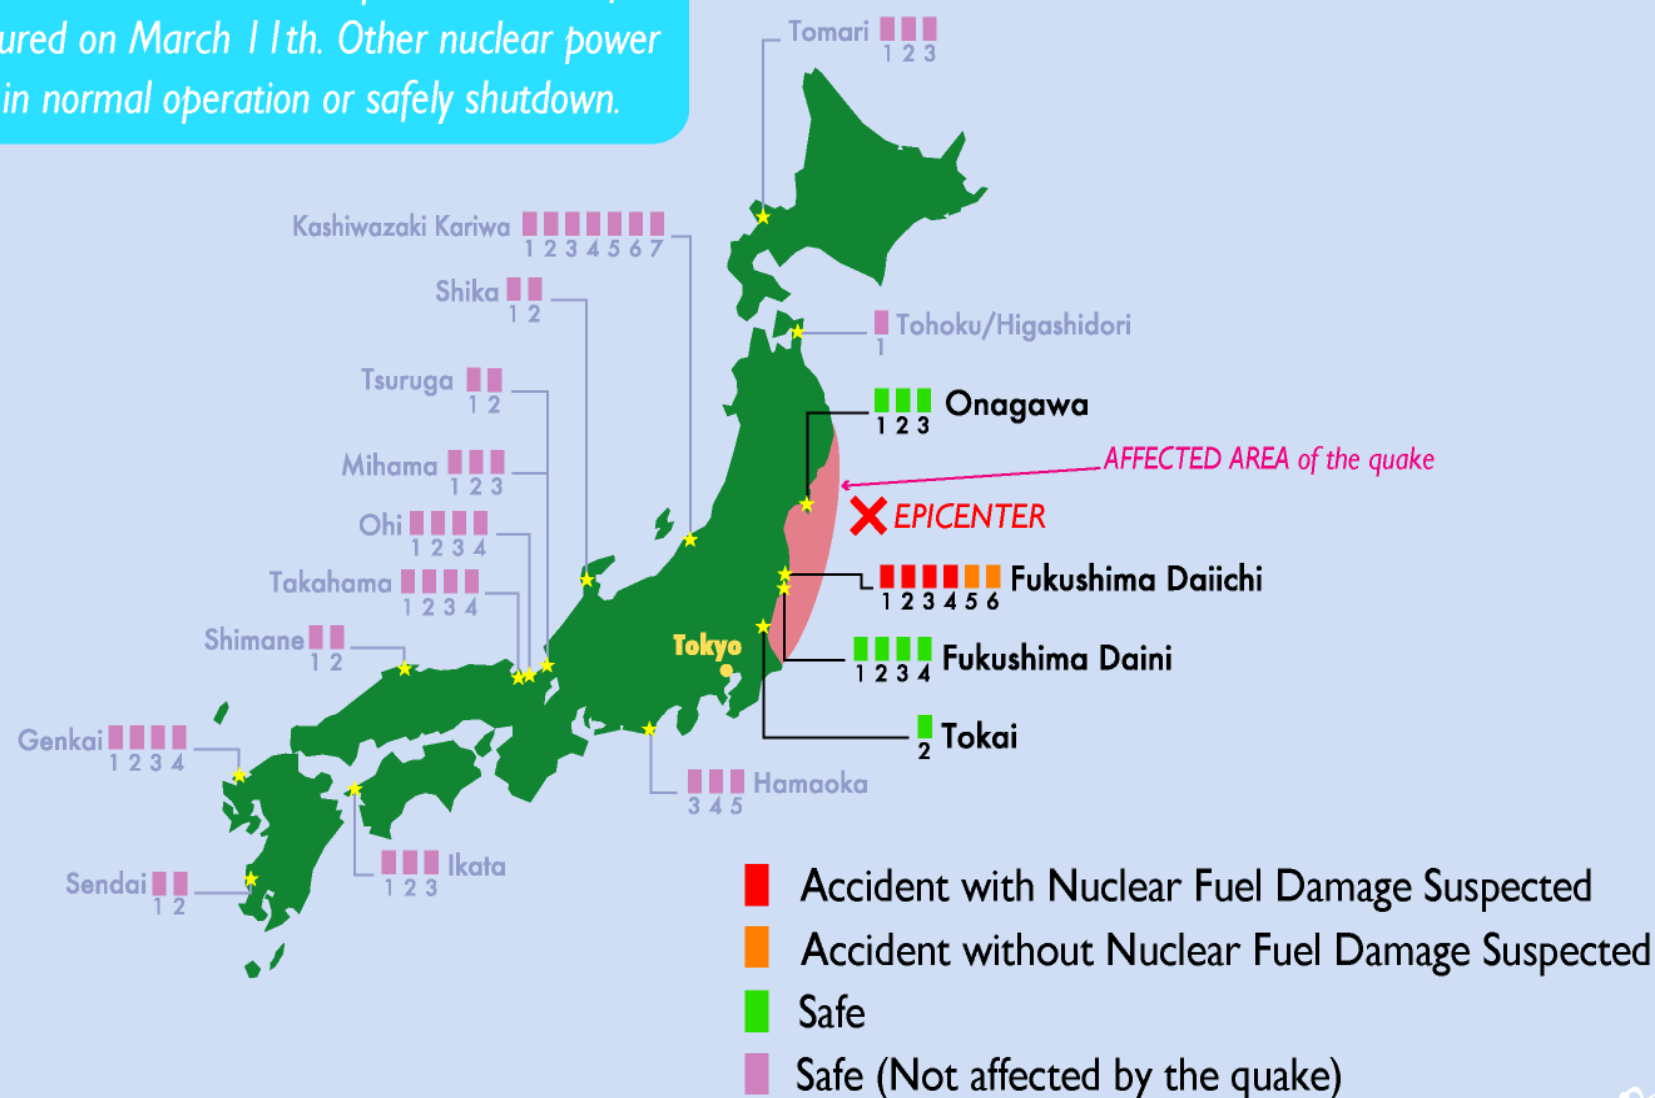
Status of the Nuclear Power Plants after the Earthquake

The accident that brings environmental impact is going on at several units in Fukushima Daiichi nuclear power Station after the earthquake occurred on March 11th. Other nuclear power plants in Japan are in normal operation or safely shutdown.
