Status of nuclear power plants in Fukushima as of 10:00 March 22 (Estimated by JAIF)

Accidents of Fukushima Dai-ichi and Fukushima-Dai-ni Nuclear Power Stations

(March 21, 2011 22:00)

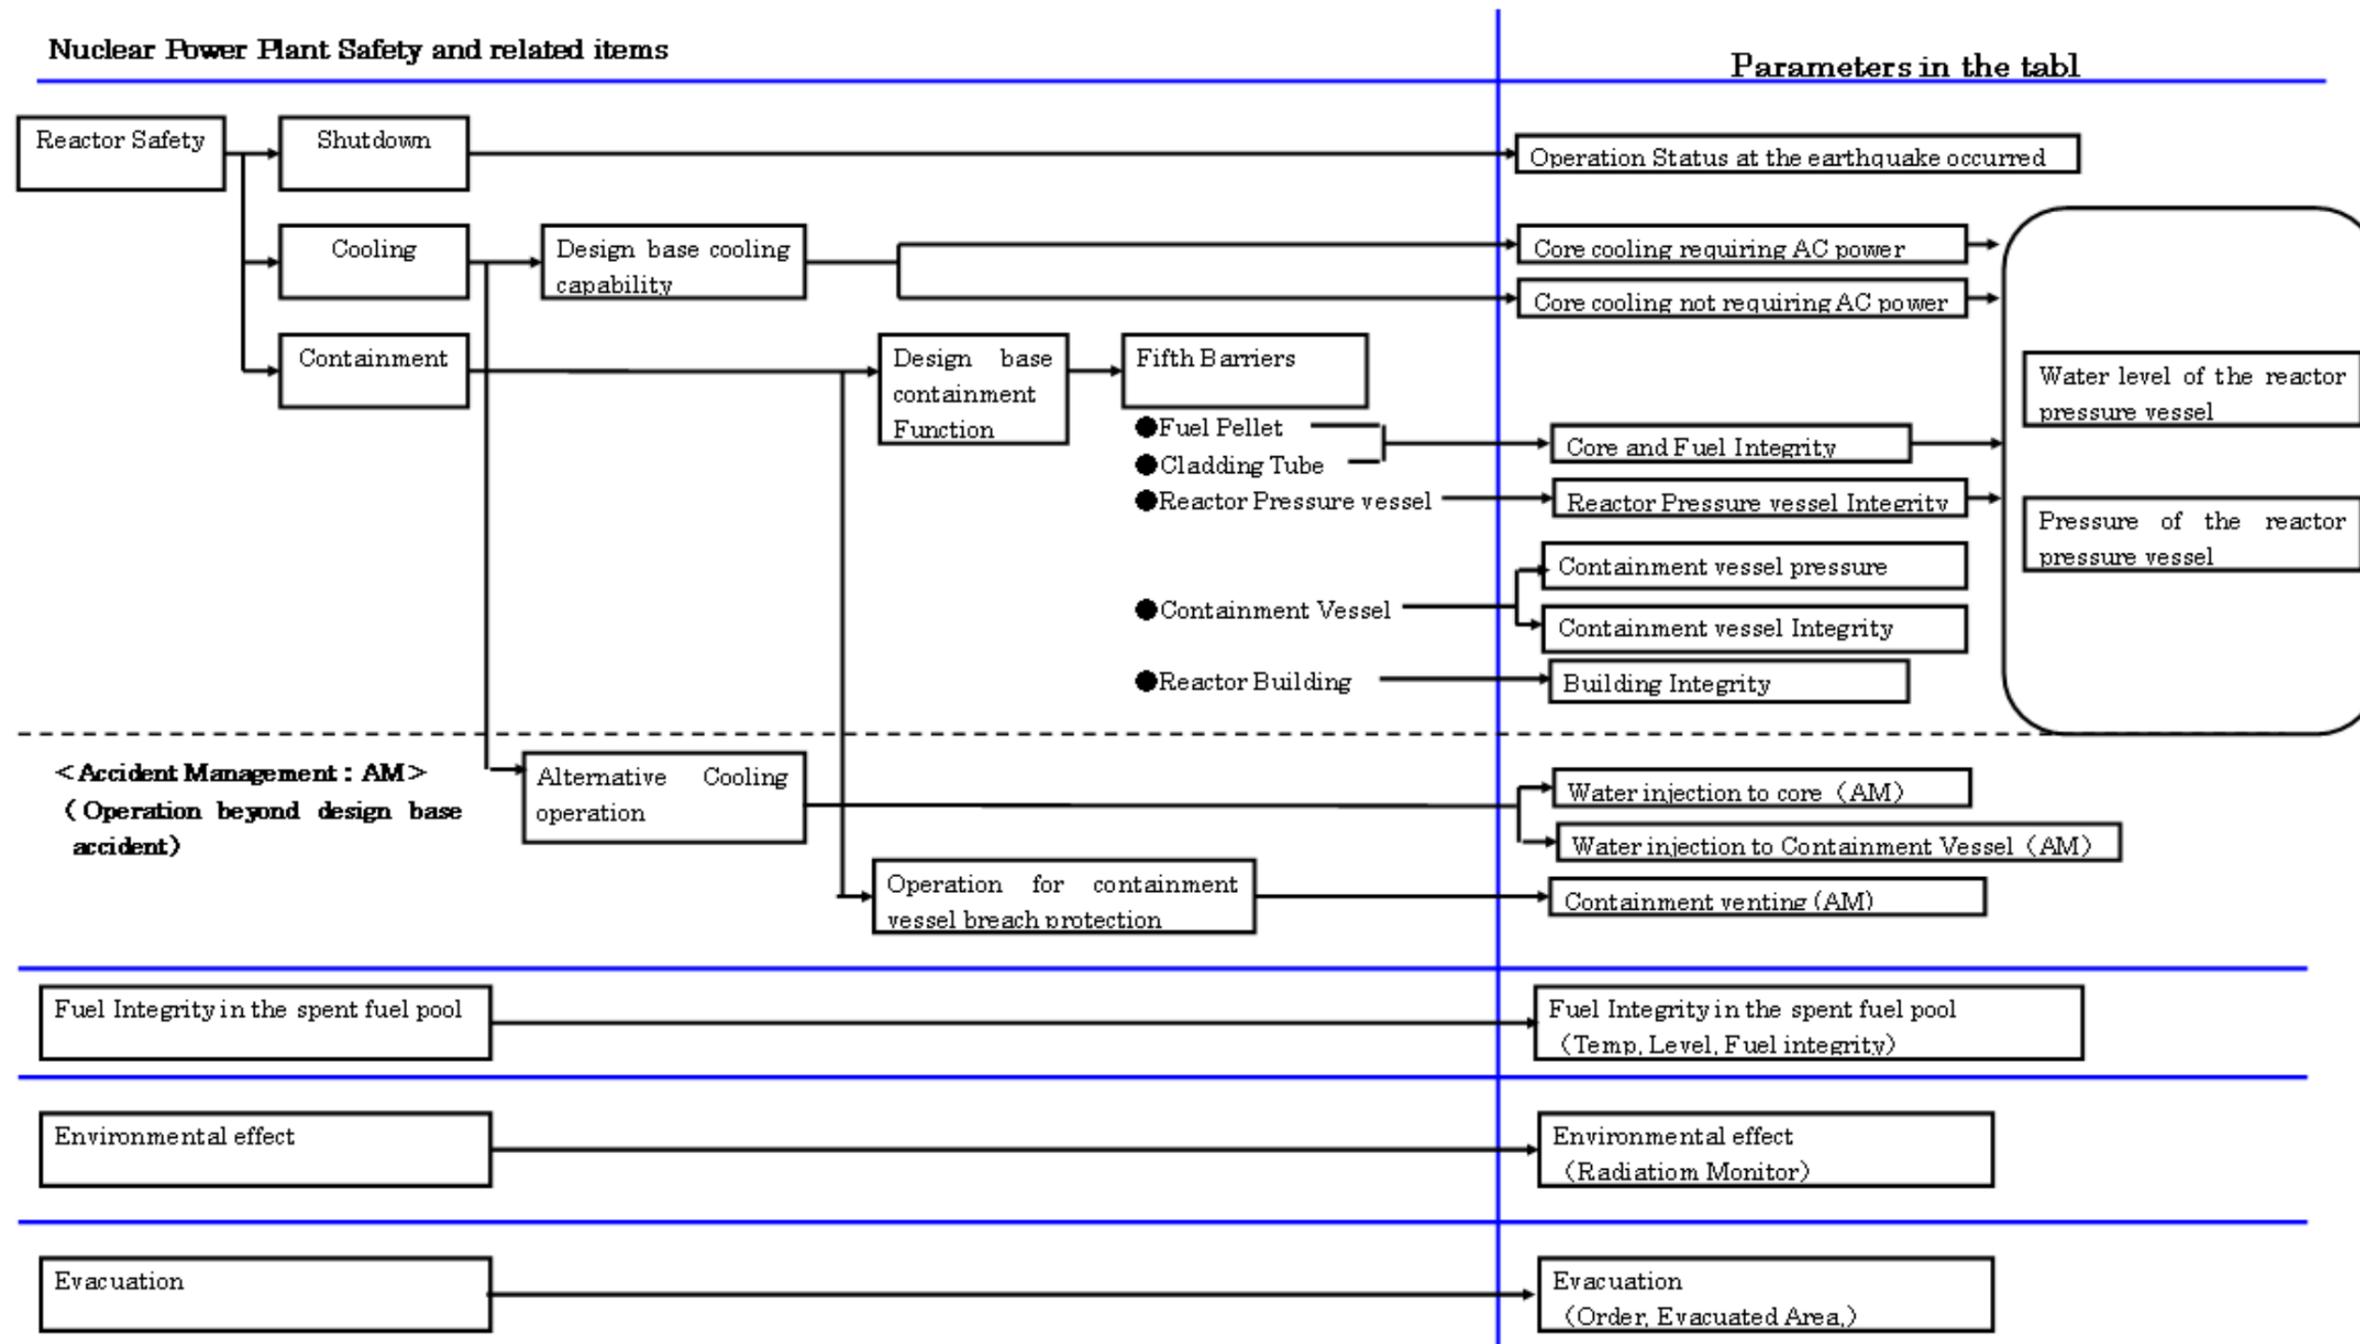
Parameters in the Table

JAIF picks up these parameters to evaluate safety condition of the nuclear plants during this accident from the view point of the principles of nuclear power plant safety, which are "Shutdown", "Cooling" and "Containment". Then we create the chart. The following diagram is to show the correspondence relation of these parameters in the table to nuclear power plant safety.

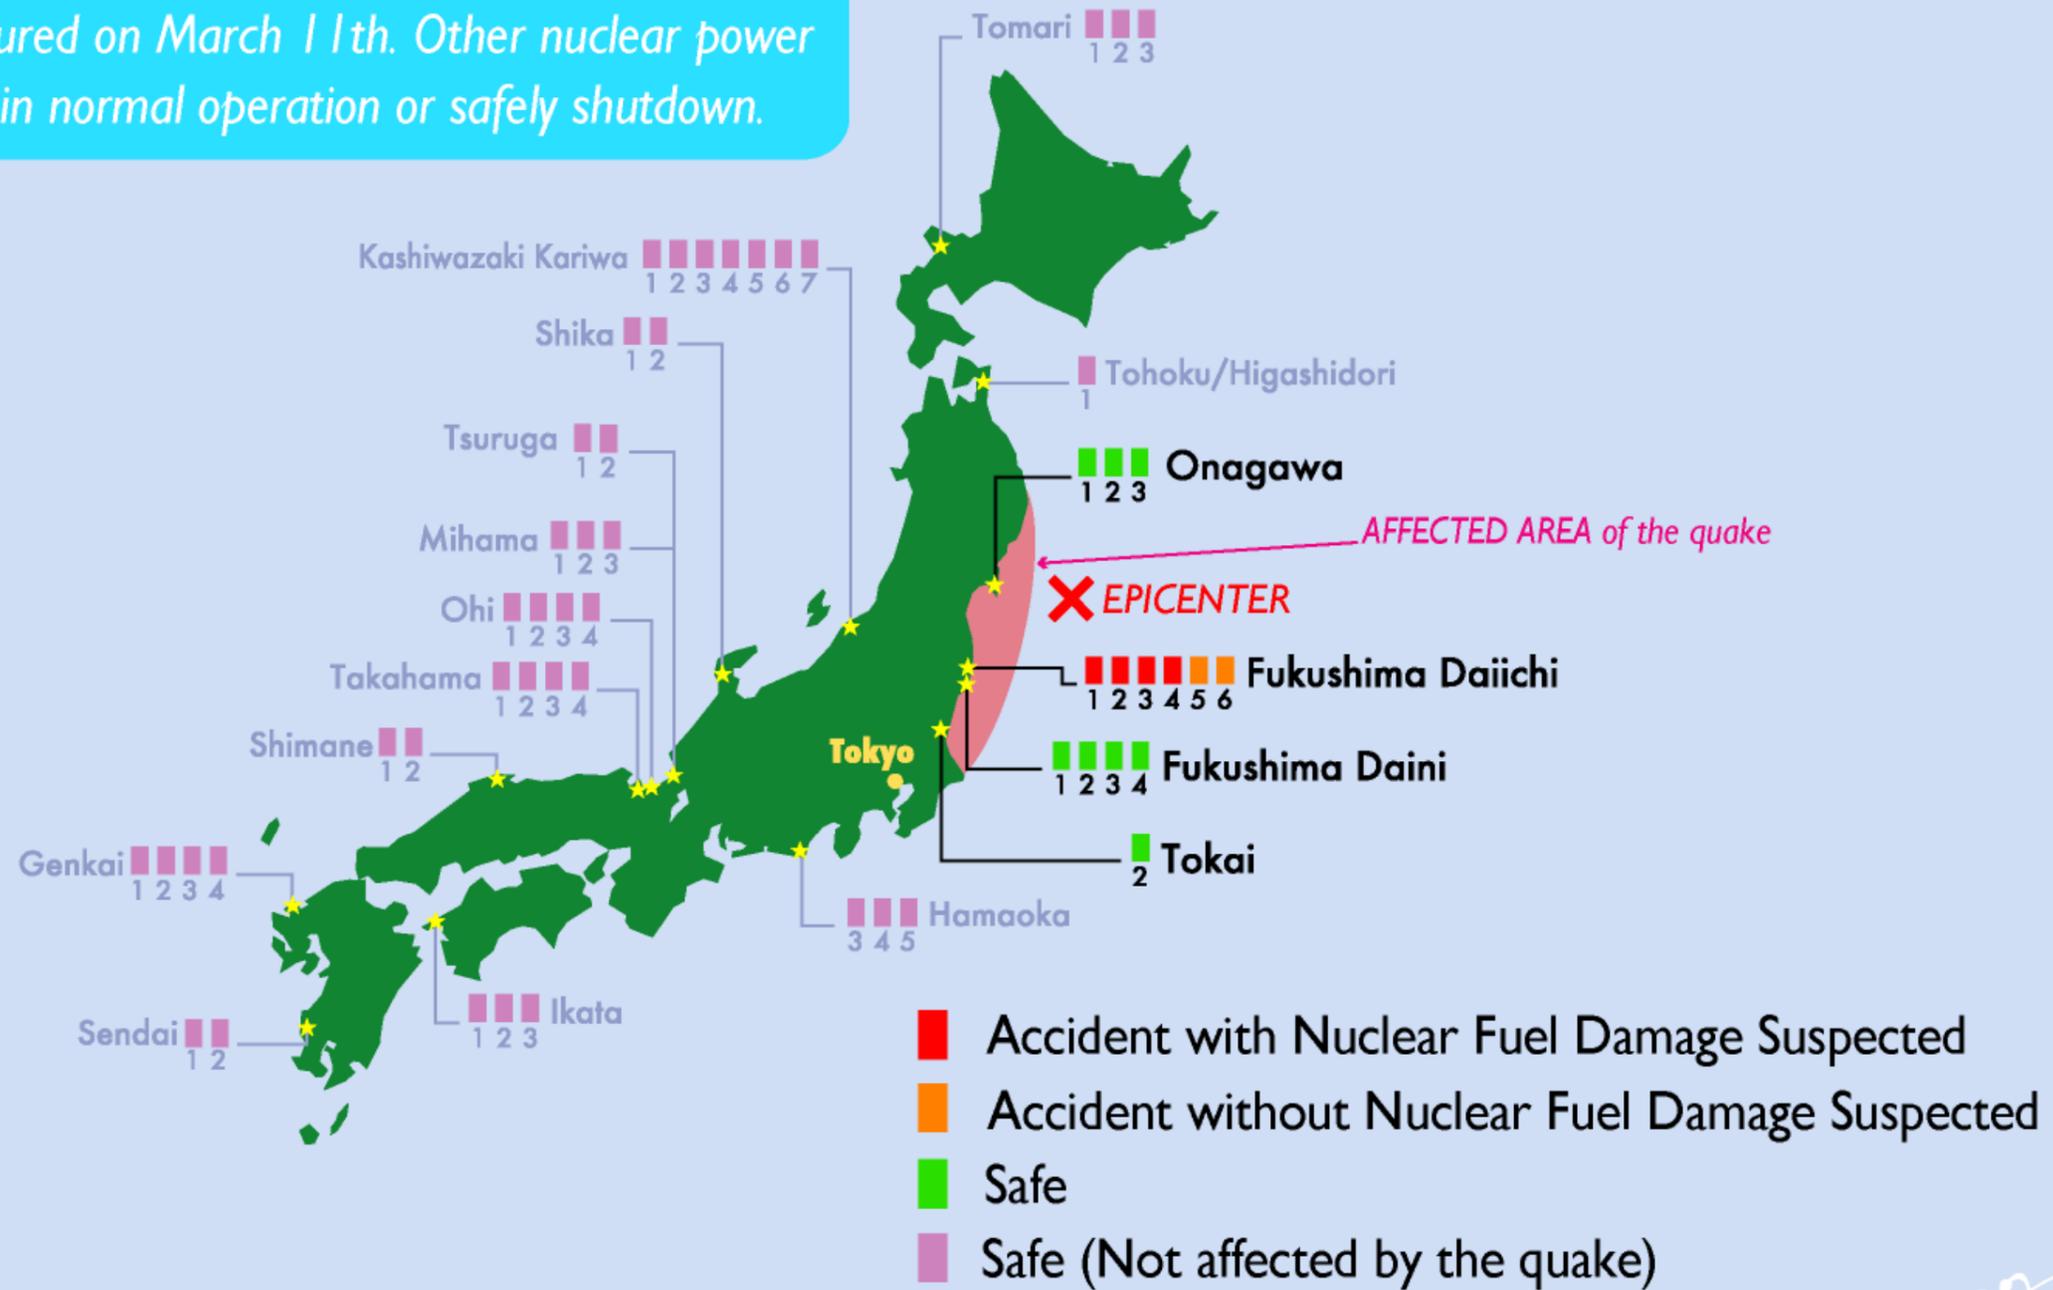
Status of the Nuclear Power Plants after the Earthquake

The accident that brings environmental impact is going on at several units in Fukushima Daiichi nuclear power Station after the earthquake occurred on March 11th. Other nuclear power plants in Japan are in normal operation or safely shutdown.
